Fukushima Daiichi Nuclear Accident;

based on the Final Report of Atomic Energy Society of Japan

Prof. Naoto Sekimura, Ph.D

Department of Nuclear Engineering and Management

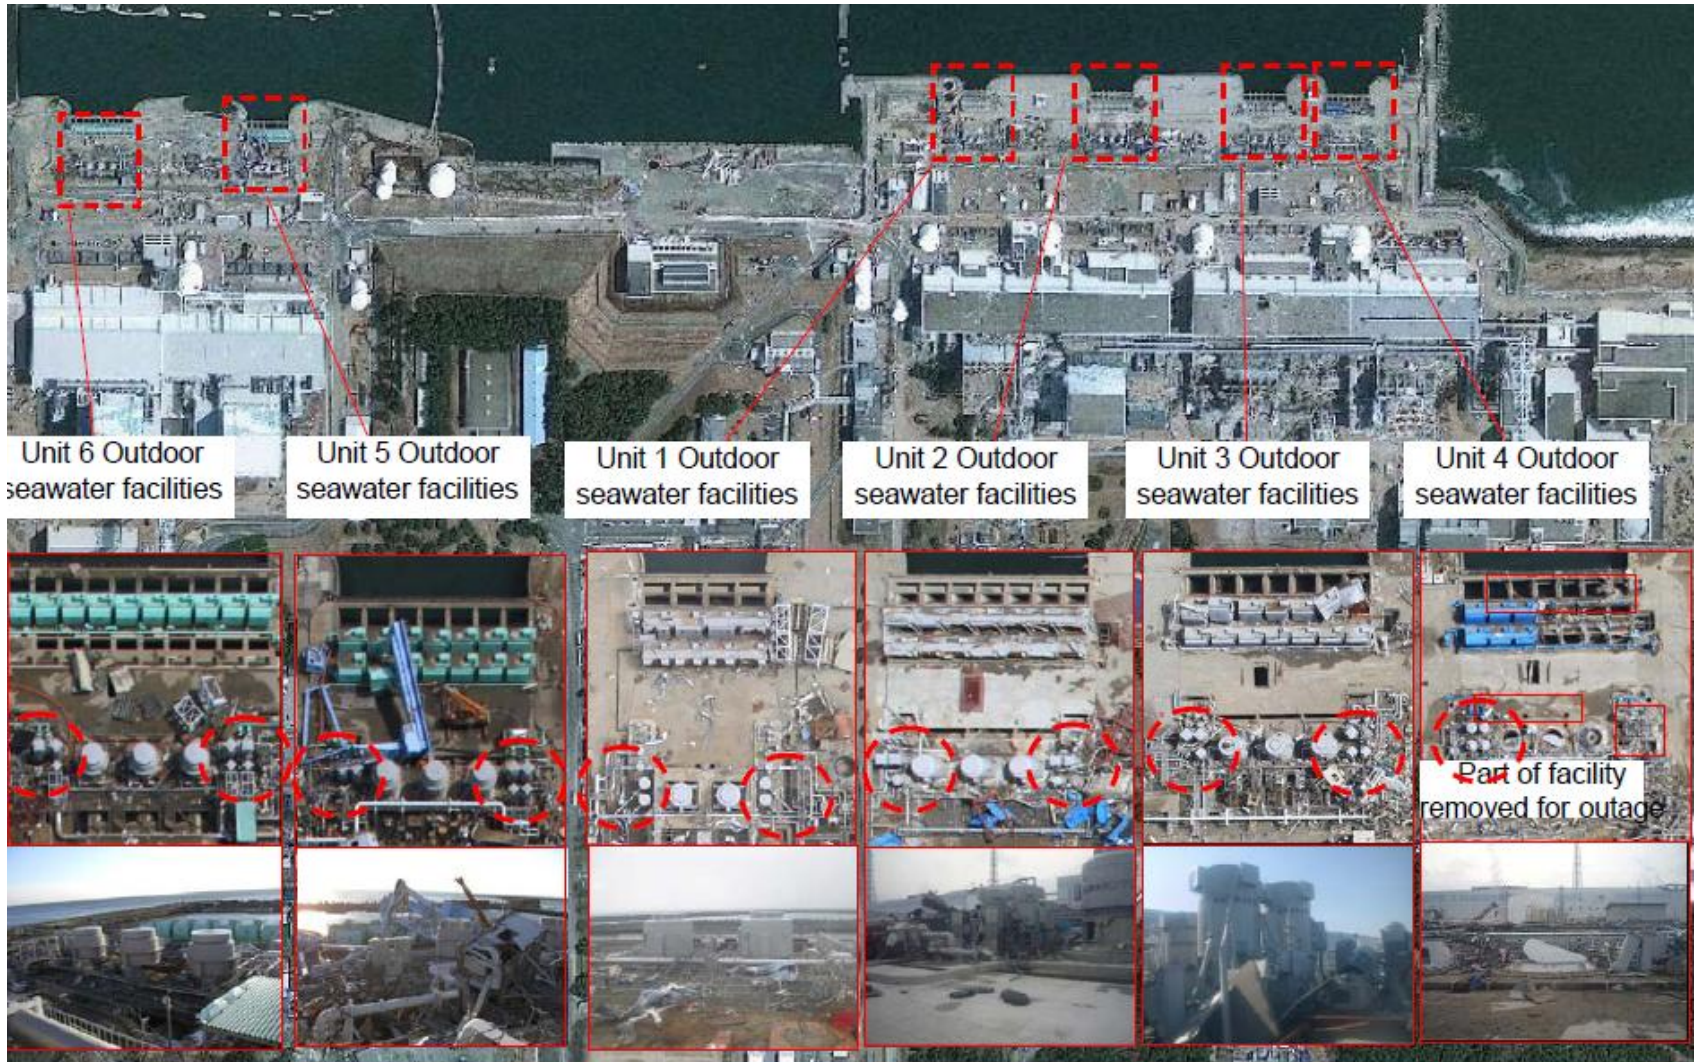
- ✓ Seawater Pumps for Ultimate Heat Sink were lost in all the 6 units.

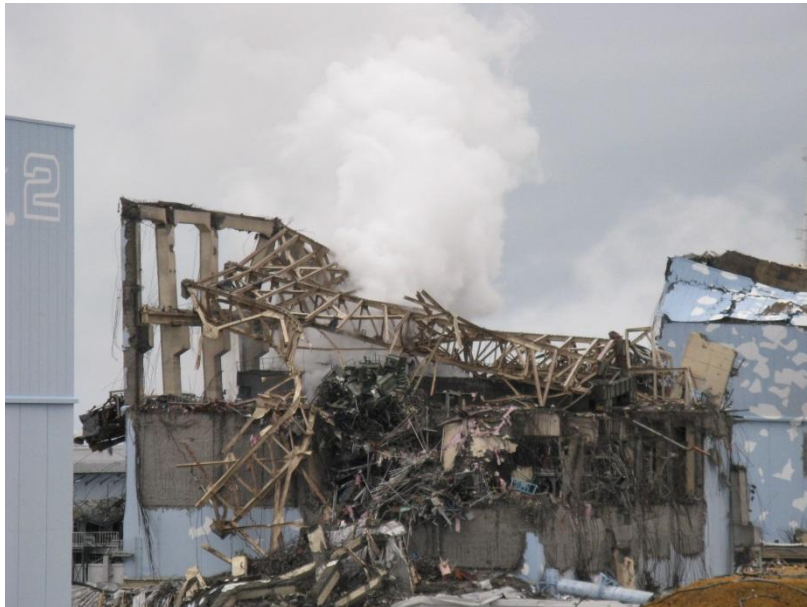
- At 11:01 on March 14, explosion occurred in Unit 3 R/B
- Hydrogen was generated due to core damage and leaked from PCV to R/B
- The hydrogen explosion injured 7 employees of TEPCO and its affiliated companies, 4 officers of Self-Defense Force that brought fresh water from off-site
- Seawater injection lines for Units 1, 2 and 3, was damaged by debris
- Circuit to control Unit 2 PCV venting that was temporary restored was also damaged.

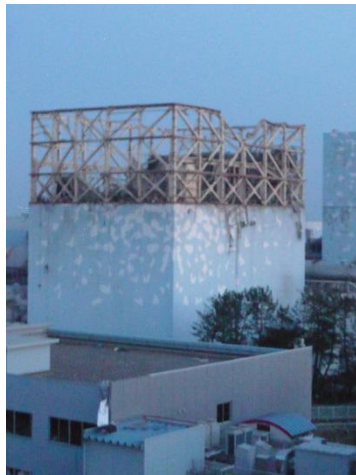
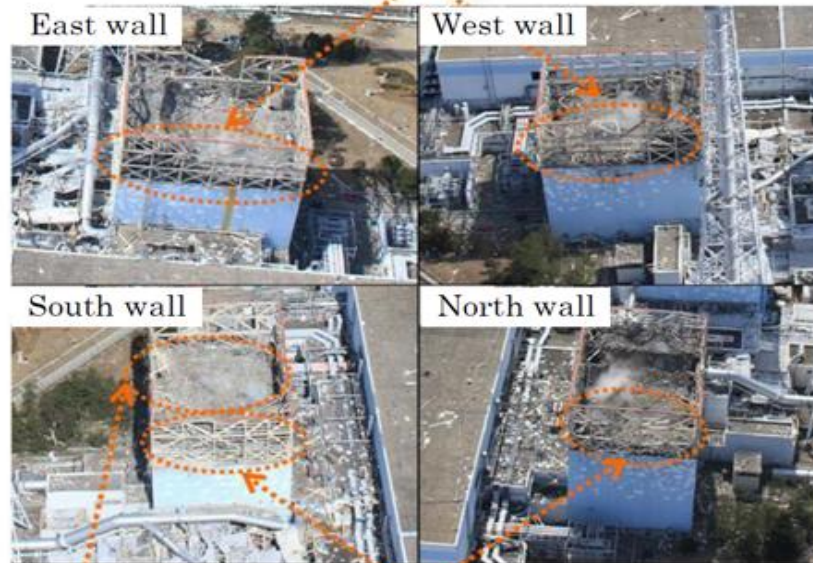
- At 21:51 on March 11, radiation dose rose in Unit 1 R/B.
- In the morning of March 12, Unit 1 PCV pressure stabilized round 750 kPa.
- At 15:36 on March 12, explosion occurred at 4th & 5th floor in Unit 1 R/B
- Hydrogen was generated due to core damage and leaked from PCV to R/B
- The hydrogen explosion injured 5 people, destroyed an high voltage power generating truck that had just been connected with the survived power distribution board in Unit 2, and sprayed debris that is highly radioactive.

All walls were damaged

Ceiling was crashed

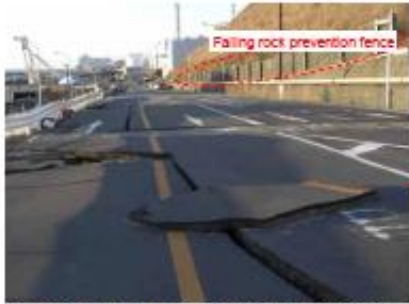
Falling rock prevention fence
One side of the road on the westside was cracked and subsided in parallel with road. West side was accessible. Photo taken 3/17

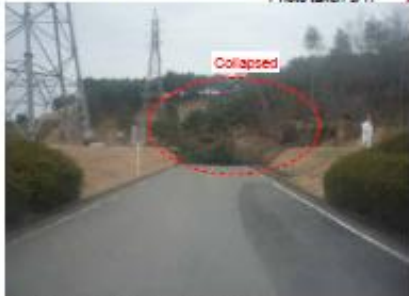
Though not a priority emergency route, the slope failed and the road was blocked and impassable. Photo taken 3/20

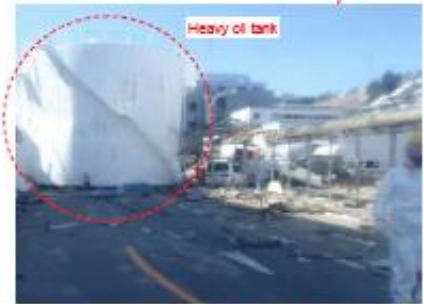
Heavy oil tank
No major damage to the road, but the heavy oil tank carried by the tsunami blocked the road making it impassable. Photo taken 3/17

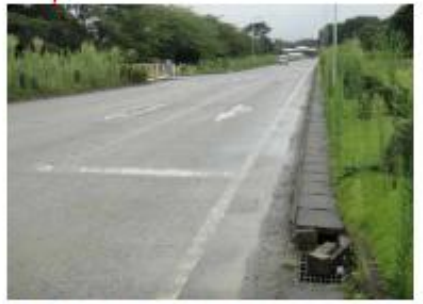
No particular abnormality found with straight road from main gate. Photo taken 8/26

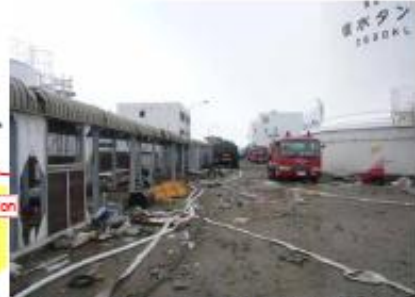
No particular abnormality with the road but scattered rubble. Photo taken 3/16

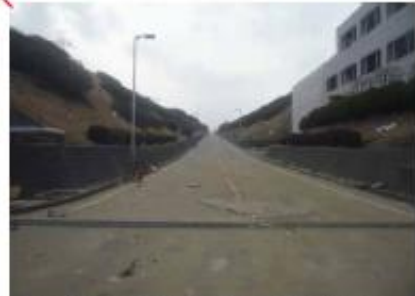
Some rubble scattered but no particular damage to roads. Photo taken 3/20

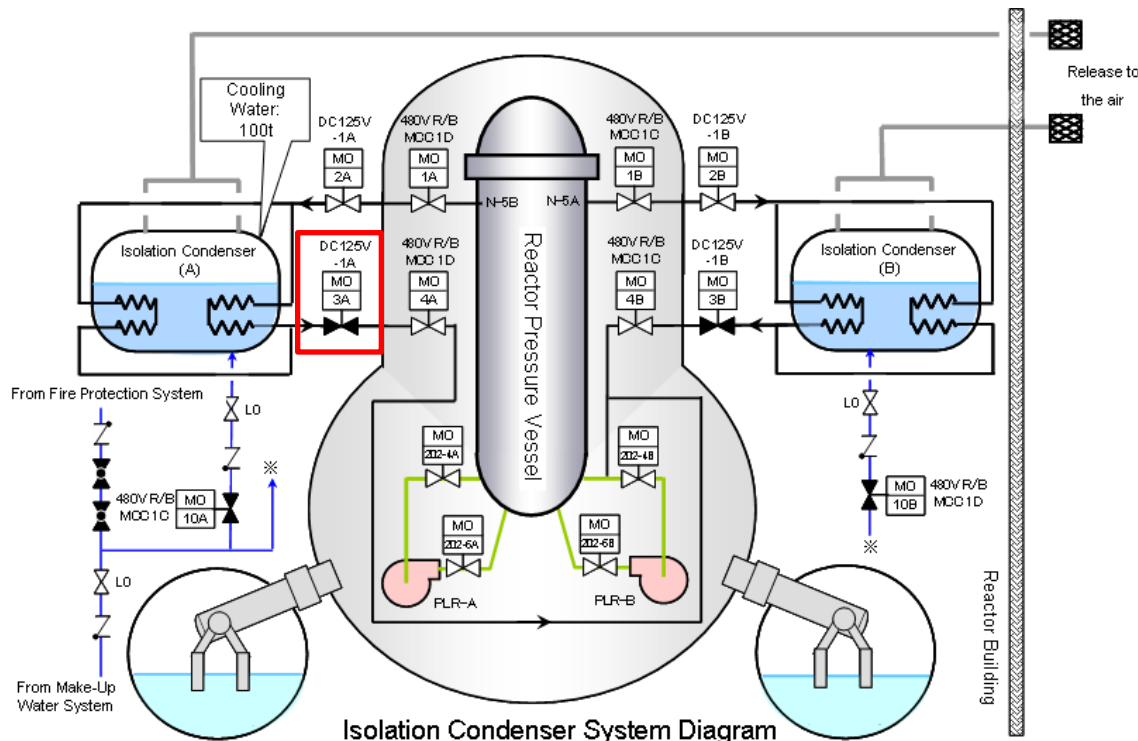
Though Unit 1 IC was a passive injection system, it lost the function due to the loss of both AC and DC power supply.

- Operator was using IC-A to control reactor pressure
- DC power for system A was lost
- Rupture detection circuit for IC-A was lost
- Valve 1A and 4A inside PCV were closed using AC power due to fail safe mechanism. IC-A lost its function
- AC power was lost. Restoration got difficult.

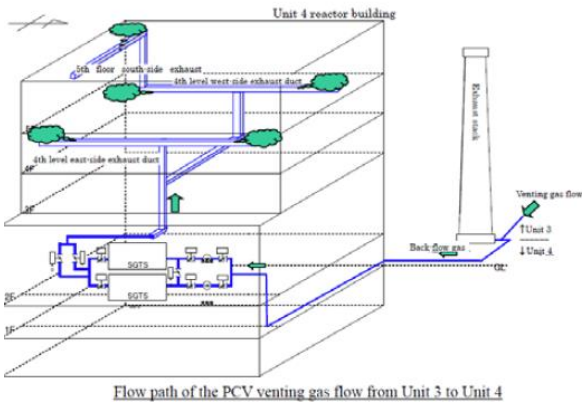
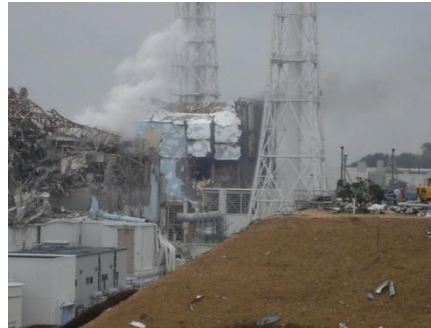
- At 6:12 on March 15, with loud noise and vibration, Unit 4 R/B was damaged.
- Later investigation showed that hydrogen generated in Unit 3 flew into Unit 4
 - There is a possible path from PCV vent line shared by Unit 3&4 through Unit 4 SGTS line into Unit 4 R/B
 - Fuels in spent fuel pool (SFP) are not damaged.

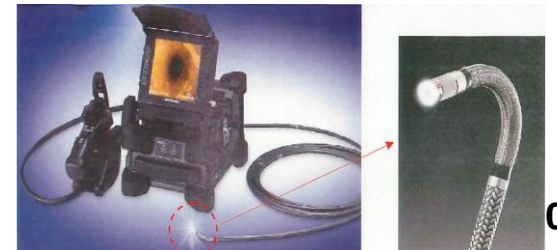
By investigations using an endoscope system, it was confirmed that:

- Water level in PCV is approx. 60 cm,
- Water temperature is approx. 50°C, and
- Dose rate of gas phase is 73 Sv/h.

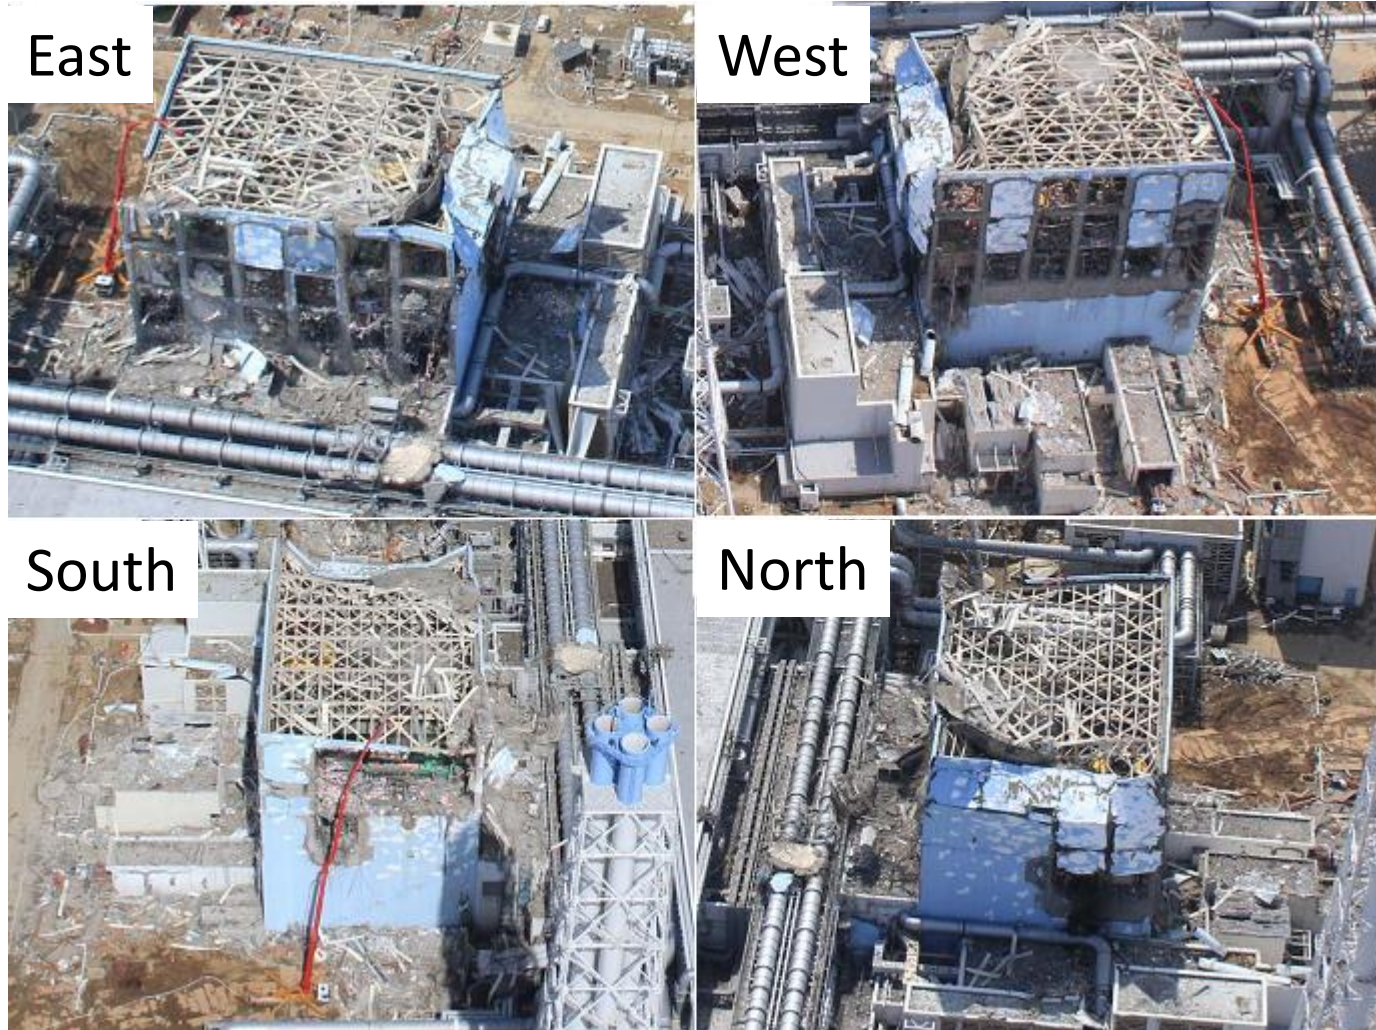
Possible mechanisms ; (1) Zr-H₂O reaction in the SFP, (2) H₂ from Unit 3,
(3) Decomposition of H₂O into H₂ and O₂ under radiation
