Research Group of Durability and Structural Safety

Carmen Andrade

Institute of Construction Sciences “Eduardo Torroja”
CSIC-Spain

CORROSION AND STRUCTURAL SAFETY GROUP

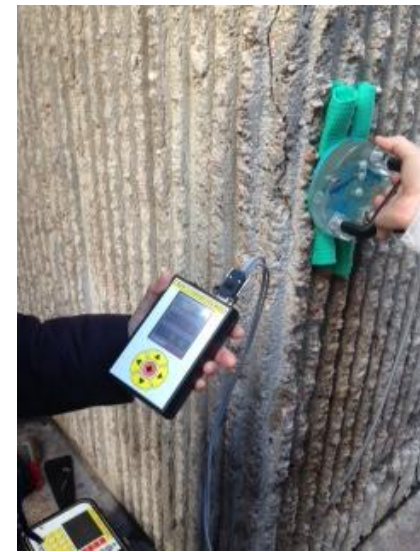
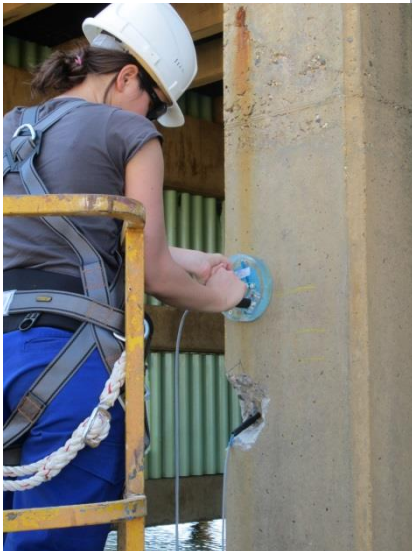
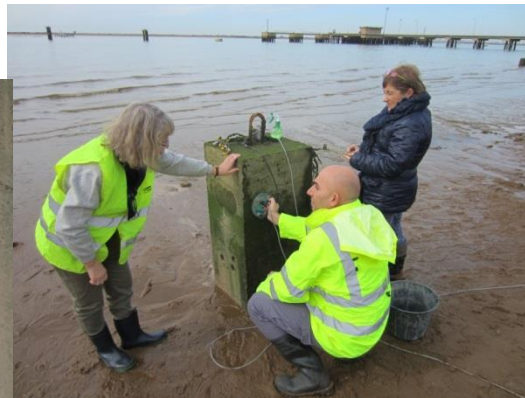
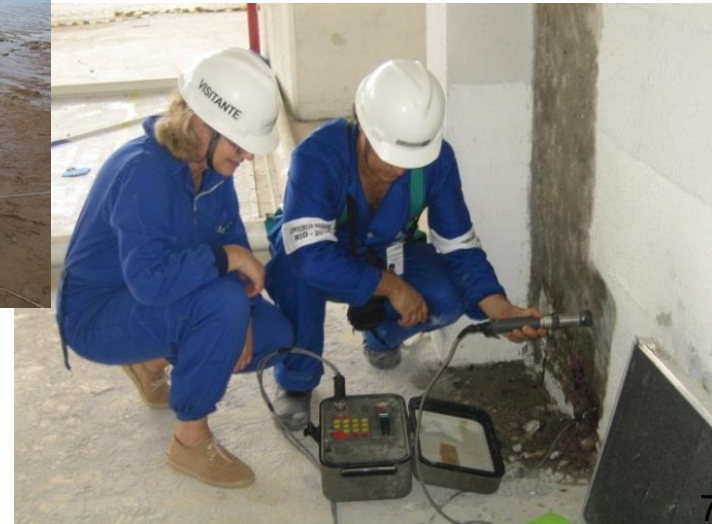
Inspection techniques

Developers of the Corrosion rate meter GECOR

- **I_{corr}: Corrosion rate $\mu\text{A}/\text{cm}^2$.**
- **E_{corr}: Corrosion Potential (mV).**
- **Resistivity ($\text{k}\Omega\cdot\text{cm}$).**

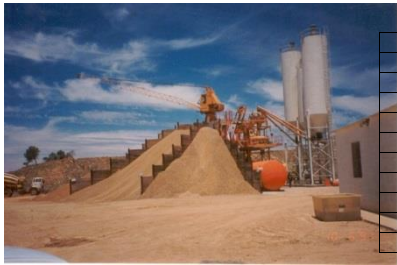
El Cabril-Cordoba disposal of m&lrw

Colaboration with Enresa-Spain from 1987
with Ondraf-Belgium from 2011

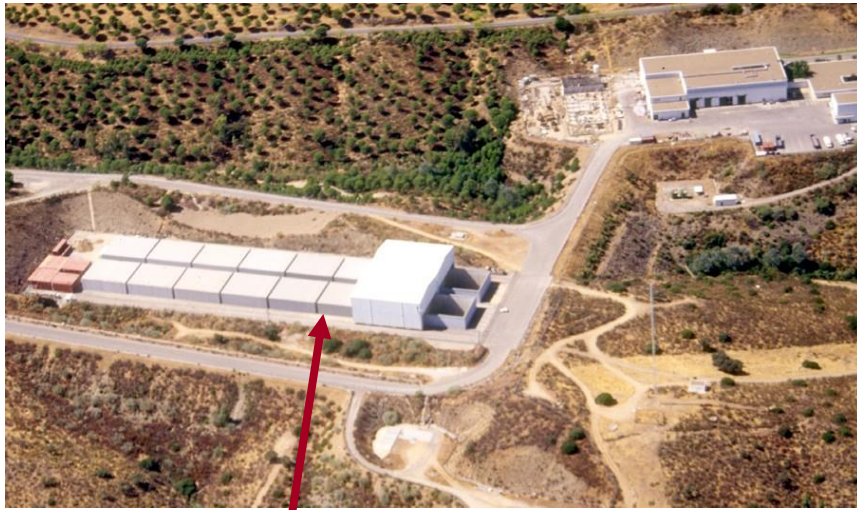
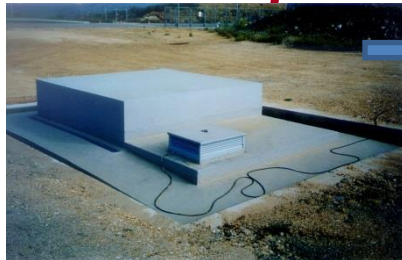
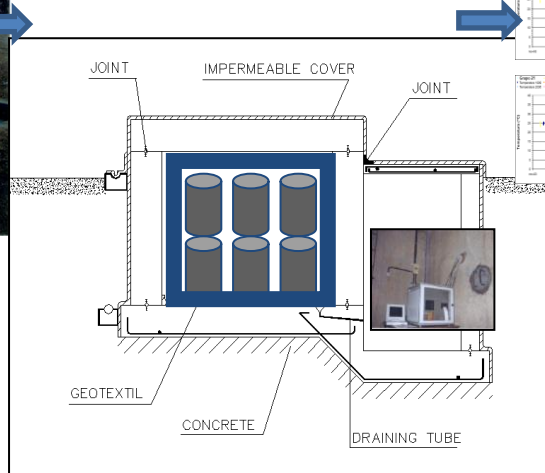
PILOT CONTAINER FOR THE MONITORING OF CONCRETE IN BURIED CONDITIONS

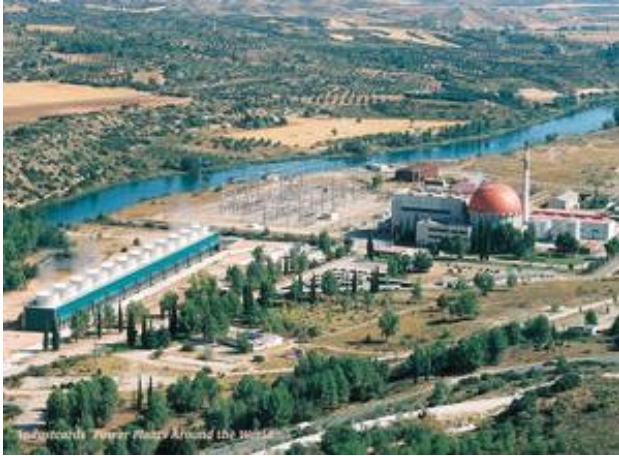
ASSESSMENT OF THE CONCRETE CONDITION IN “JOSE CABRERA” NUCLEAR POWER STATION AFTER DISMANTELING

- It was commissioned in 1968, and it operated until 2006

- On february 2010, ENRESA took the responsibility for decommissioning the station

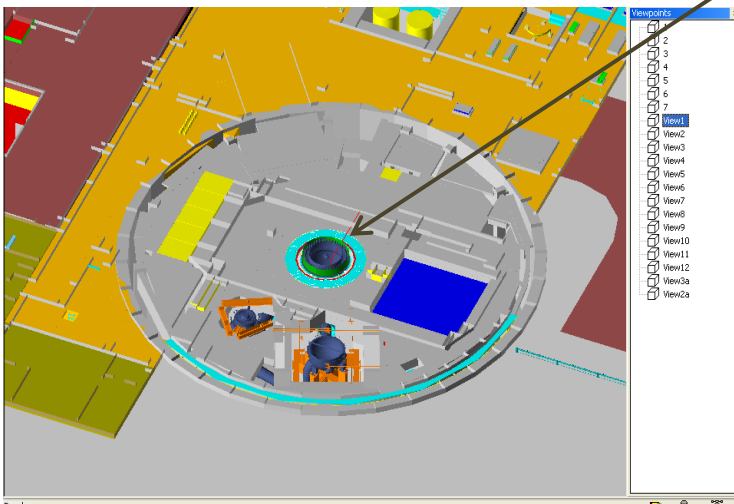
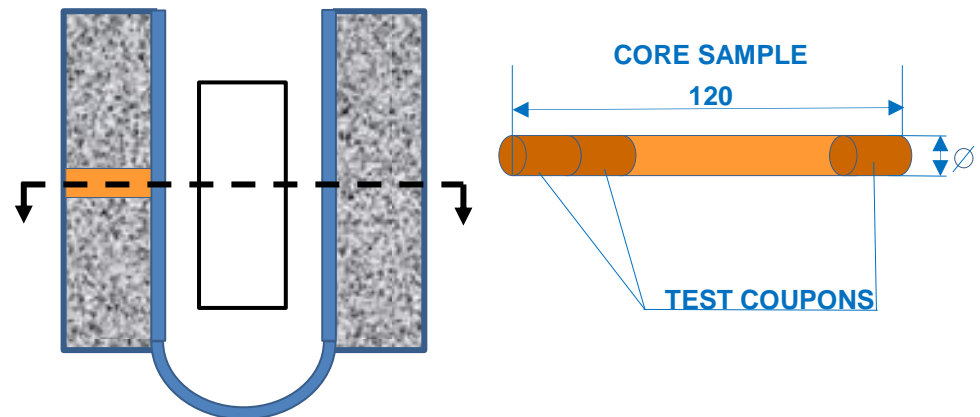
Biological shielding. Core samples (irradiated):
