Fukushima Daiichi Nuclear Accident;

based on the Final Report of Atomic Energy Society of Japan

Prof. Naoto Sekimura, Ph.D

Department of Nuclear Engineering and Management

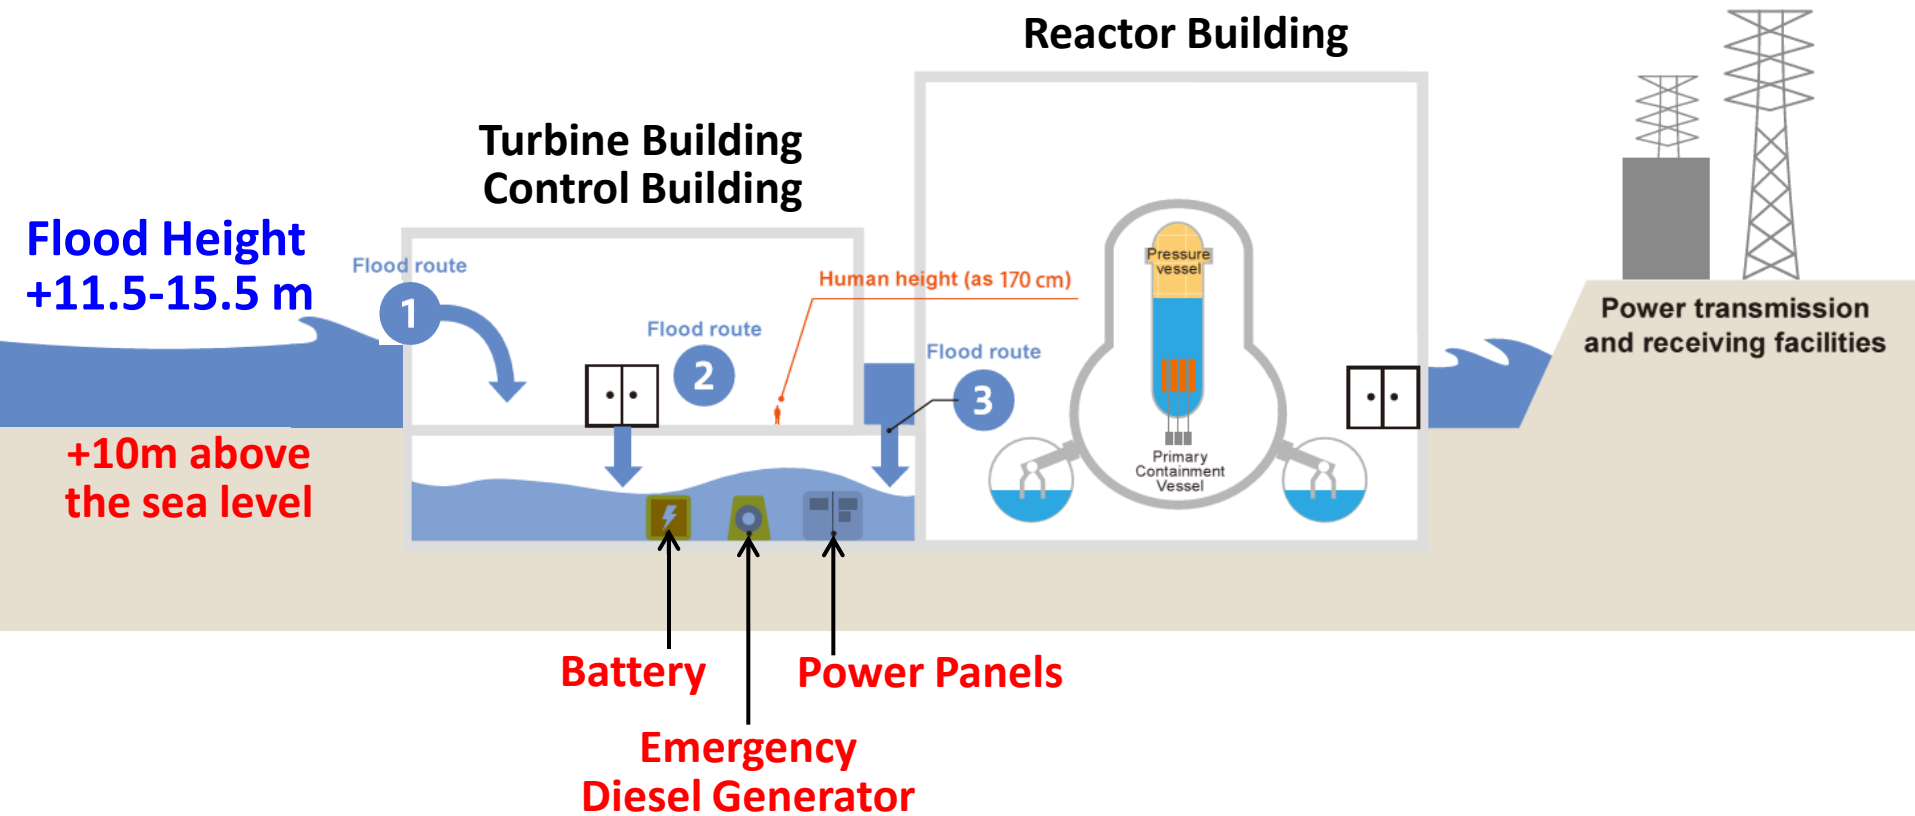
Tsunami Flood in Units 1-4

Assumption of Tsunami Height was Max. 6.1 m before the Accident.

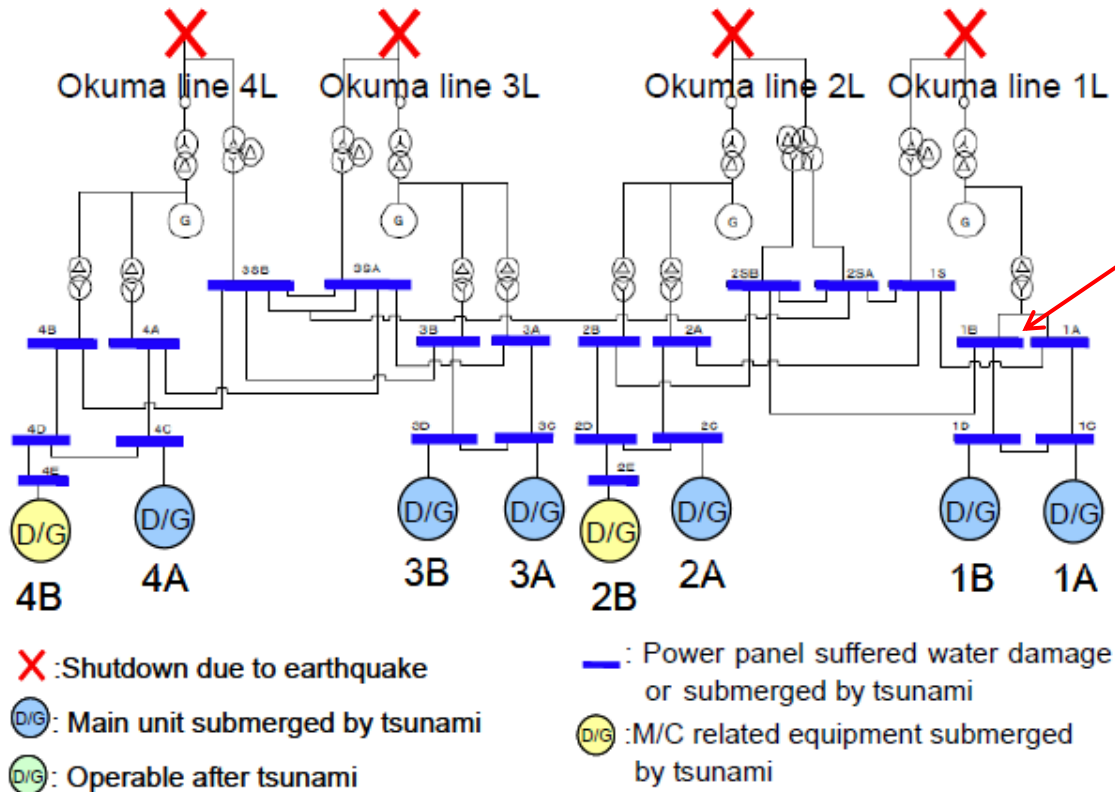
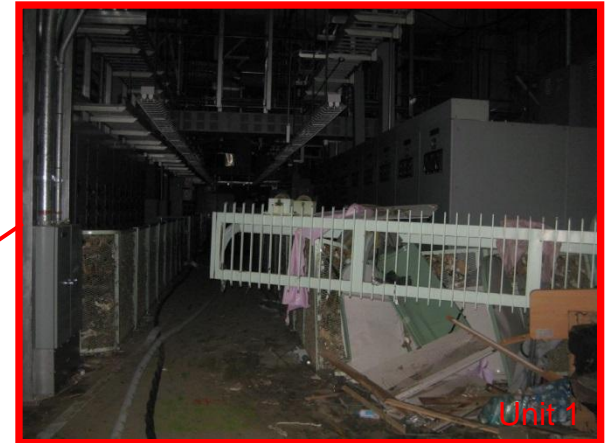
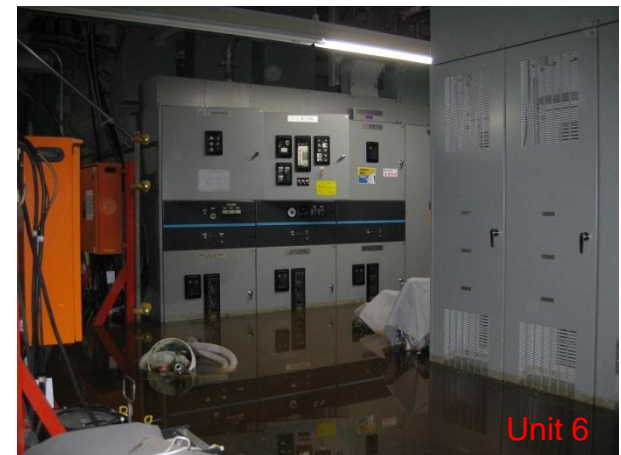
Influence of the Tsunami Flooding on Electric Power Distribution Systems

- All AC power (high voltage line of 6.9kV, low voltage line of 480 V and 120 V) were lost in Units 1, 2, 3, 4 and 5.
- Main DC bus (125 V) was lost in Units 1, 2 and 4.

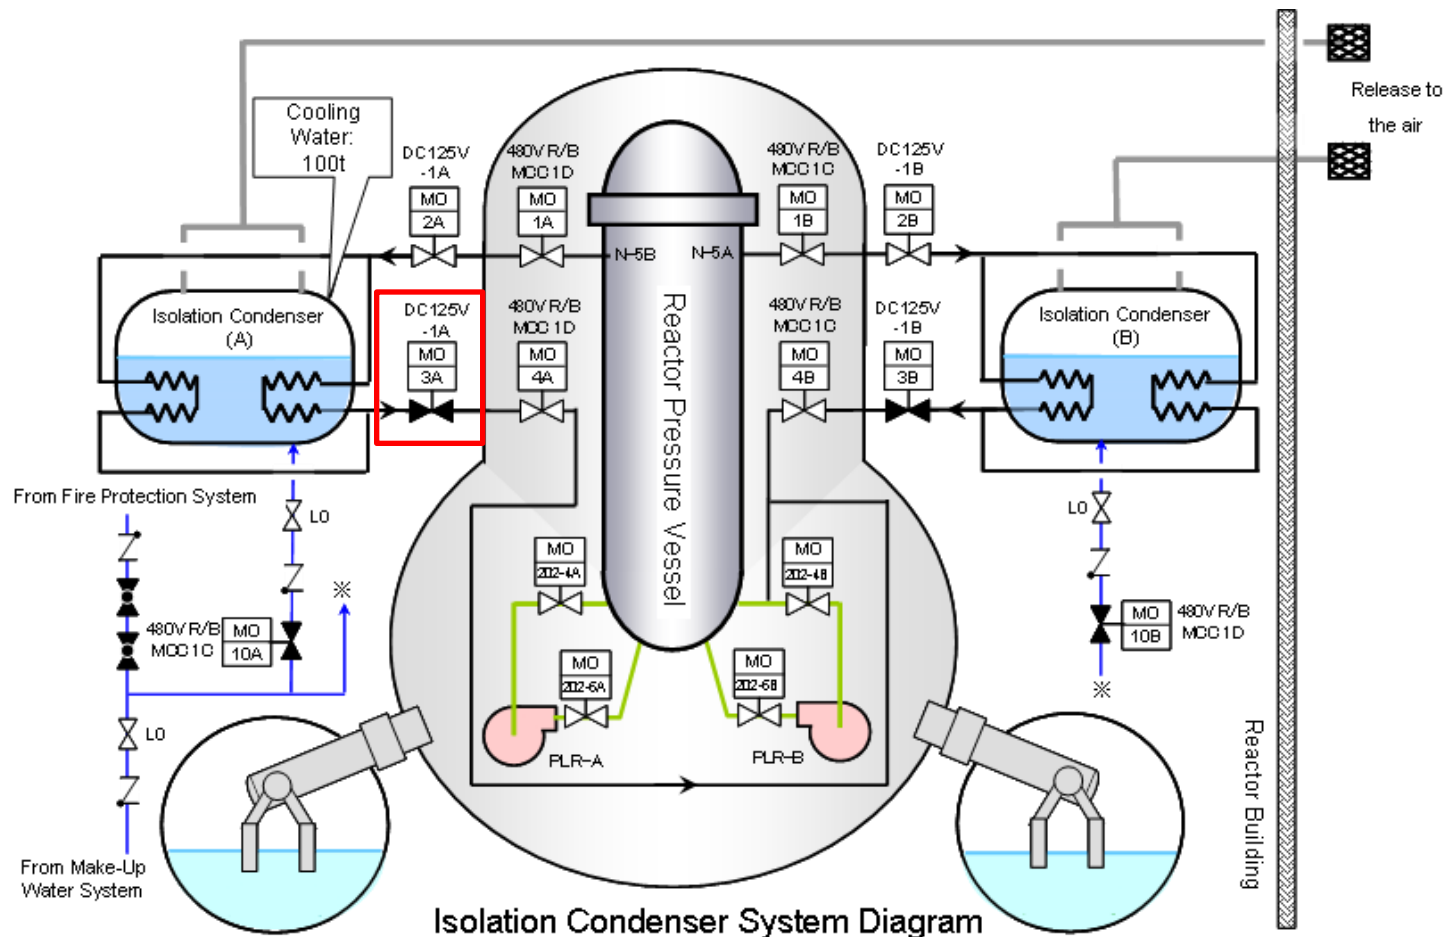
Isolation Condenser (IC) in Unit 1

Core damage in Unit 1 progressed in a short period of time after the tsunami. The status of the IC, which is used to cool the reactor in the initial stages after shutdown, have affected the event progression.

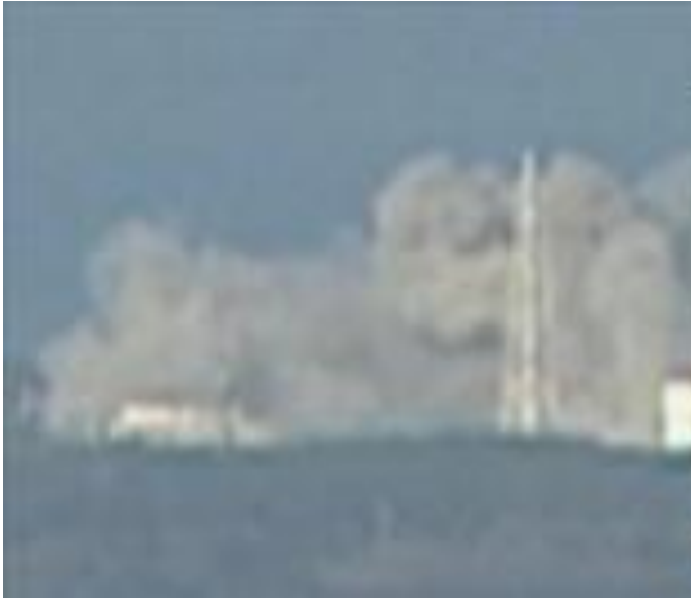
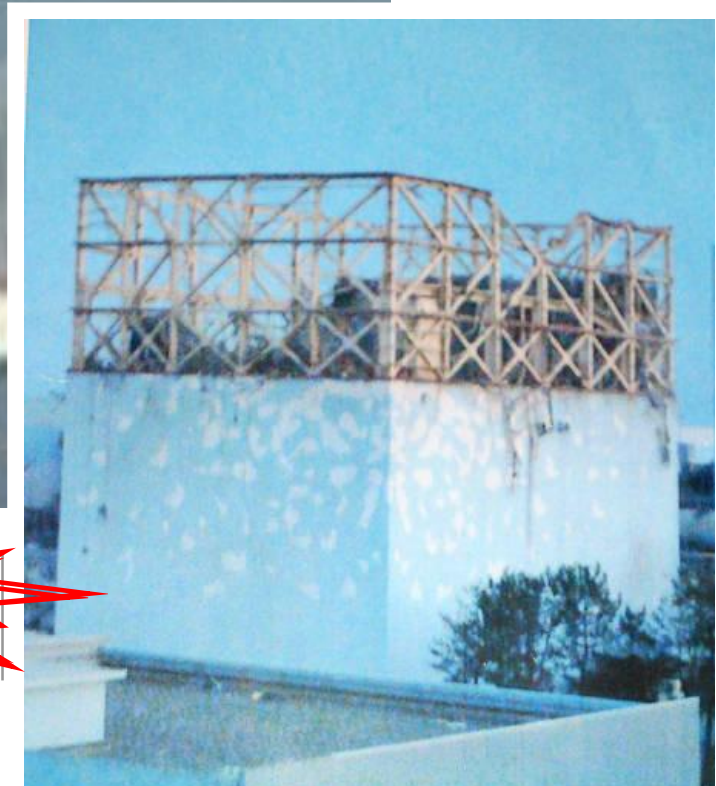
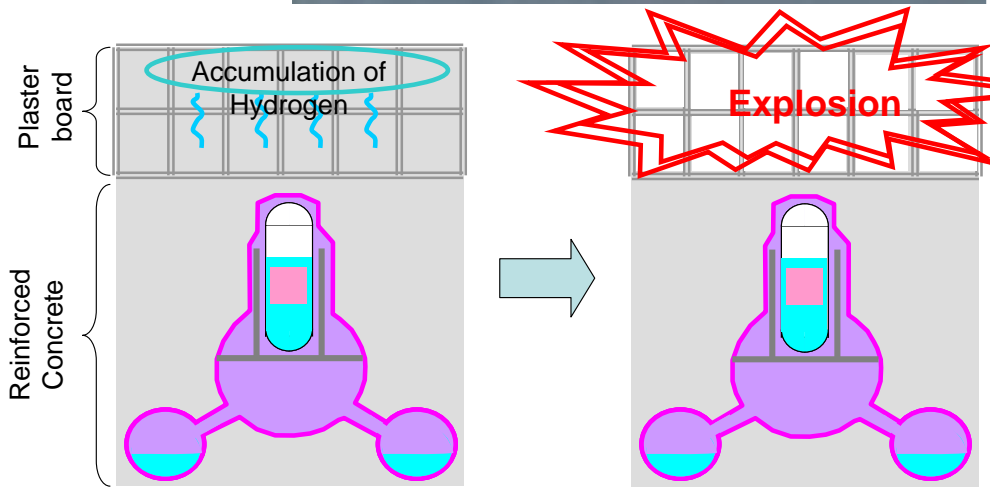
Hydrogen Explosion in Unit 1 at 15:36 on March 12, 2011

- At 21:51 on March 11, radiation dose rose in Unit 1 R/B.
- In the morning of March 12, Unit 1 PCV pressure stabilized round 750 kPa.
- At 15:36 on March 12, explosion occurred at 4th & 5th floor in Unit 1 R/B
- Hydrogen was generated due to core damage and leaked from PCV to R/B
- The hydrogen explosion injured 5 people, destroyed an high voltage power generating truck that had just been connected with the survived power distribution board in Unit 2, and sprayed debris that is highly radioactive.

All walls were damaged

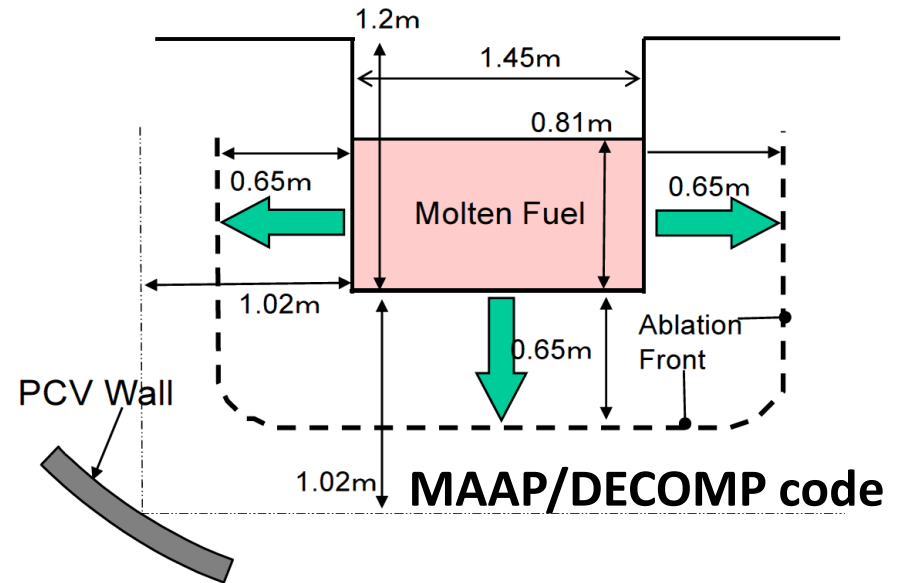
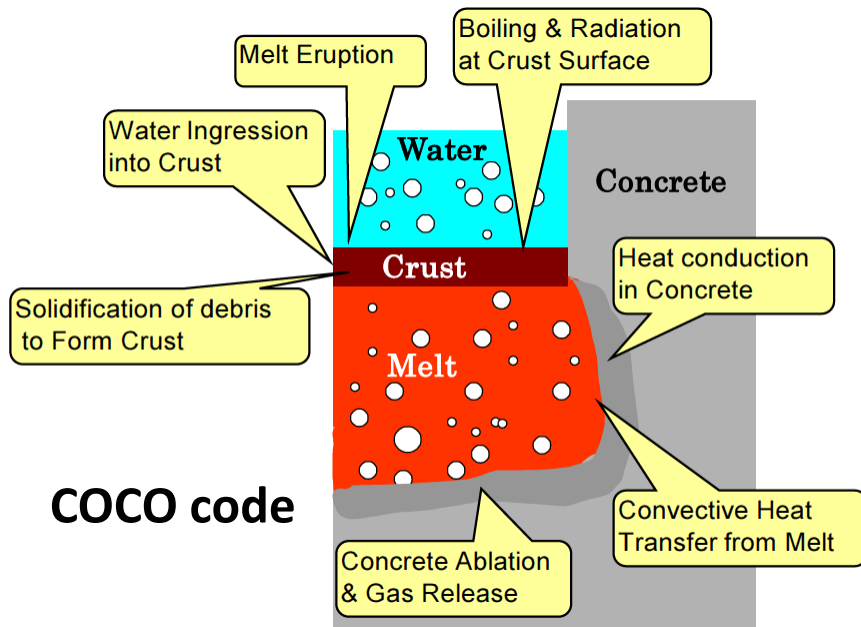
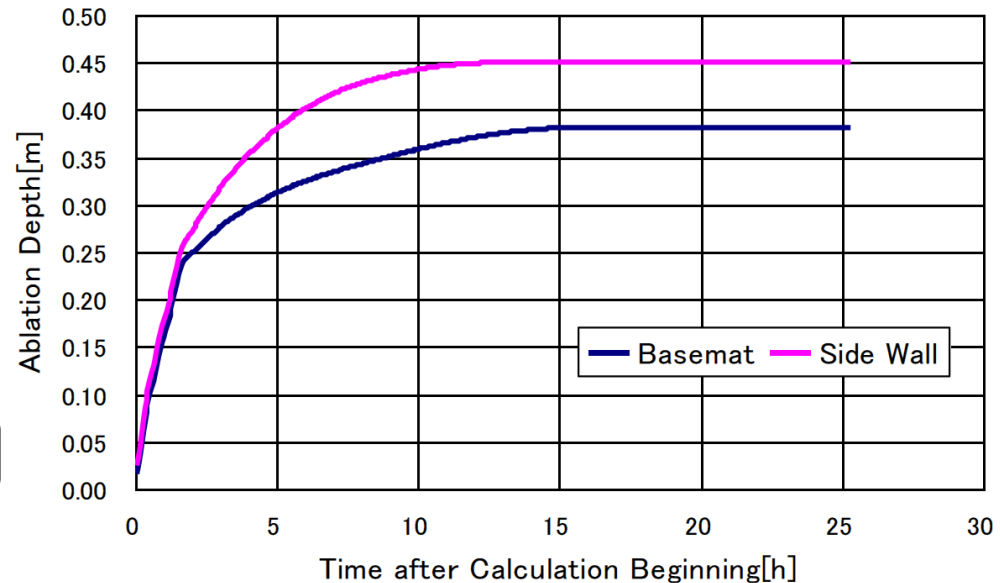
Estimated Ablation Depth

- ✓ MAAP/DECOMP code
0.65 m
- ✓ COCO code
0.45 m : Basement
0.38 m : Side Wall

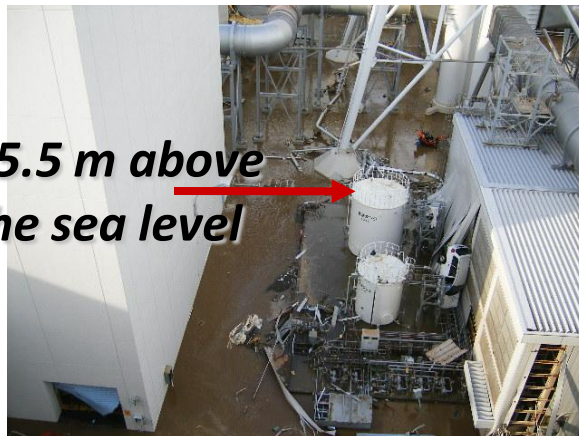
15.5 m above
the sea level

Inundation height of the Tsunami in Fukushima Daiichi was about 15.5 m above the sea level.

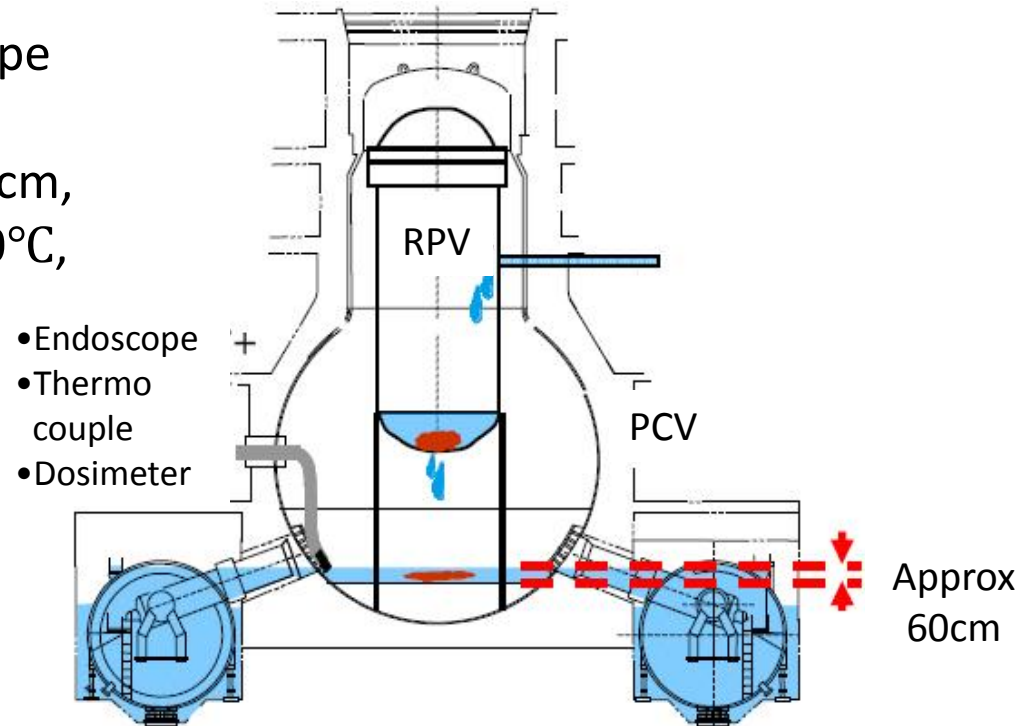
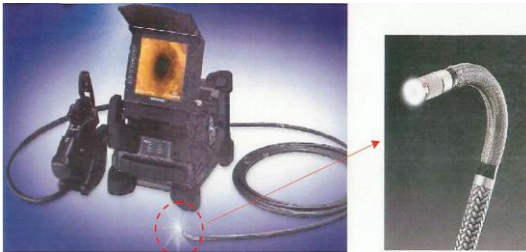
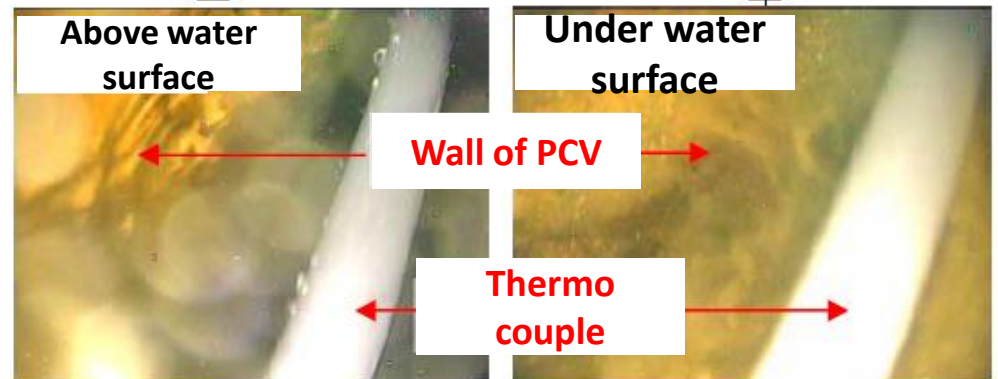
Investigation Result of the Inside of PCV of Unit 2

By investigations using an endoscope system, it was confirmed that:

- Water level in PCV is approx. 60 cm,
- Water temperature is approx. 50°C,
- and
- Dose rate of gas phase is 73 Sv/h.

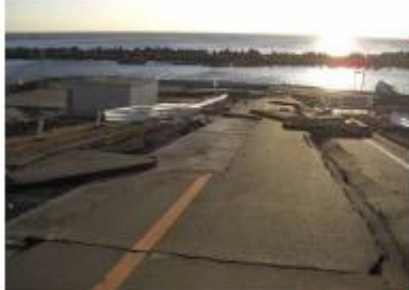
Reinforcement work was conducted on this road, but cracks and subsidence was found on both sides of the road which were not reinforced. Photo taken 3/17

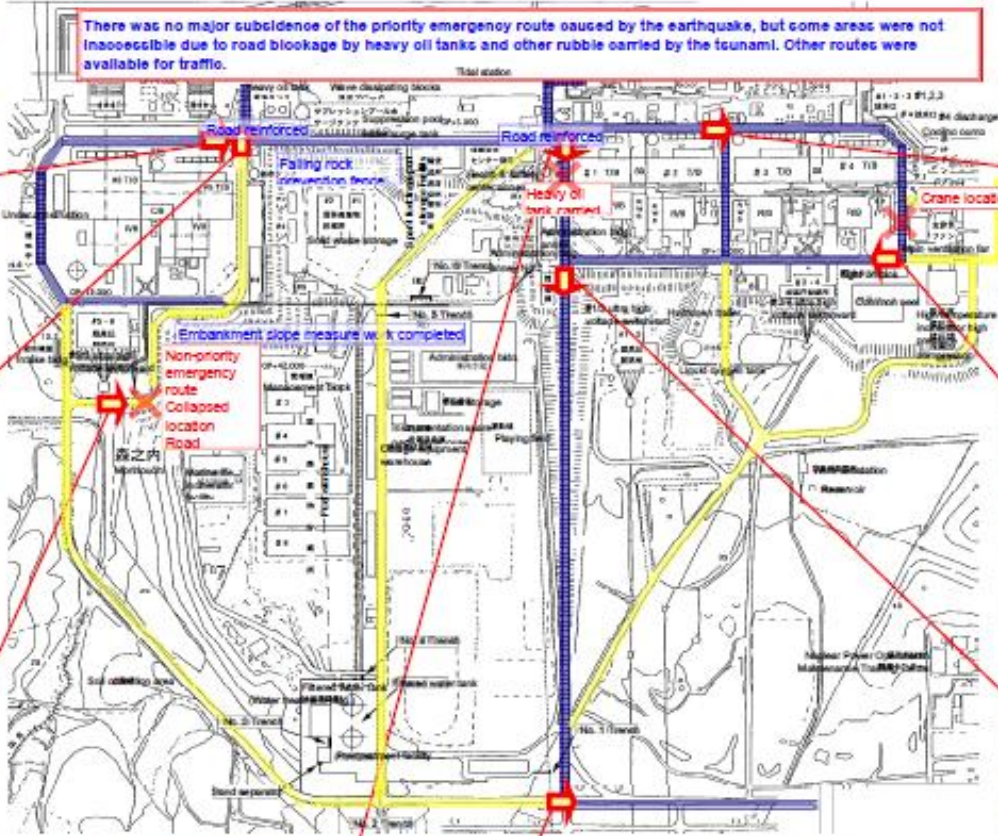
Though not a priority emergency route, the slope failed and the road was blocked and impassable. Photo taken 3/20

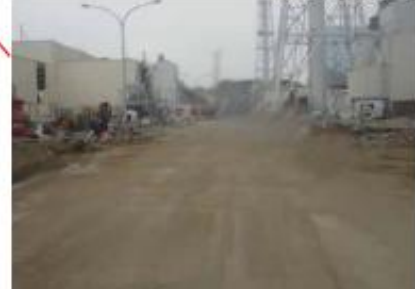
No particular abnormality with Units 1 to 4 west side road. Rubble was scattered when Units 1, 3, 4 R/B were damaged. Photo taken 3/20

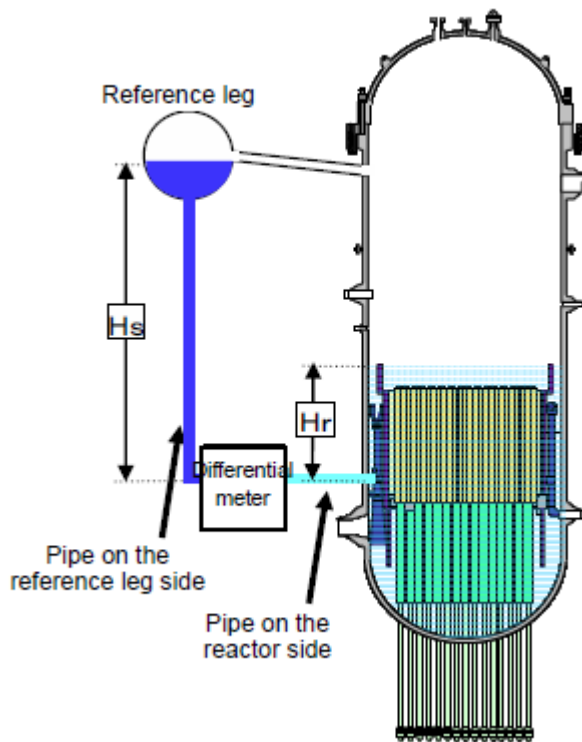
Water gauges measure the difference of pressure between the Reference leg and the water phase of the reactor

Water gauges required calibration when the reference leg was dried-off or water level decreased significantly

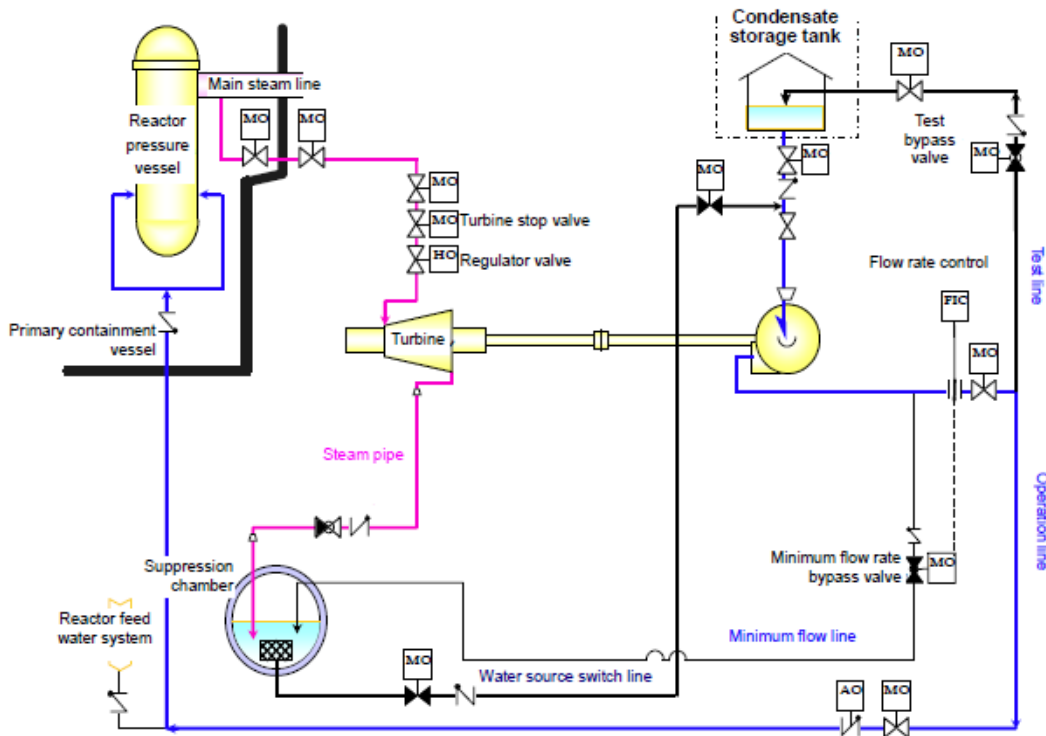
RCIC in Unit 2 Sustained the Function after Loss of DC Power

Though Unit 2 RCIC was not a passive injection system, it had partly sustained the function after the loss of power supply until March 14

- When power for RCIC was lost, the valves for RCIC operation was open
- RCIC did not stop the operation due to the loss of the automatic control
- RCIC turbine was driven by two-phase flow when water level was higher than the limit

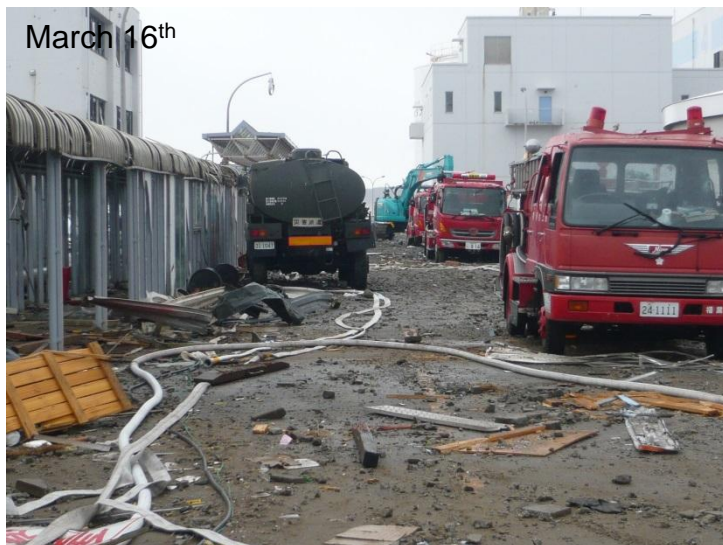
Cooling Unit 2 Reactor Core

- While Unit 2 RCIC was functioned,
 - SRV control panel was powered by potable batteries on March 13 to depressurize after RCIC stop
 - Seawater injection line was prepared using fire engine
 - PCV vent line was completed except the break of rupture disk
- But these measures were damaged by hydrogen explosion in Unit 3.
- At 13:25 on March 14, loss of RCIC was confirmed.
- Since S/C temperature exceeded 100 °C and the steam would not condense easily, decision was made to depressurized after venting was lined up.

- At 14:43, connection of fire engine was restored, but restoration of venting took time.
- At 16:21, the president of TEPCO ordered to depressurize at first, but SRV did not worked well until 18:02.
- At 19:20, shutdown of fire engine due to the lack of fuel was confirmed.
- At 19:57, two fire engines started up, and sea water injection was commenced.

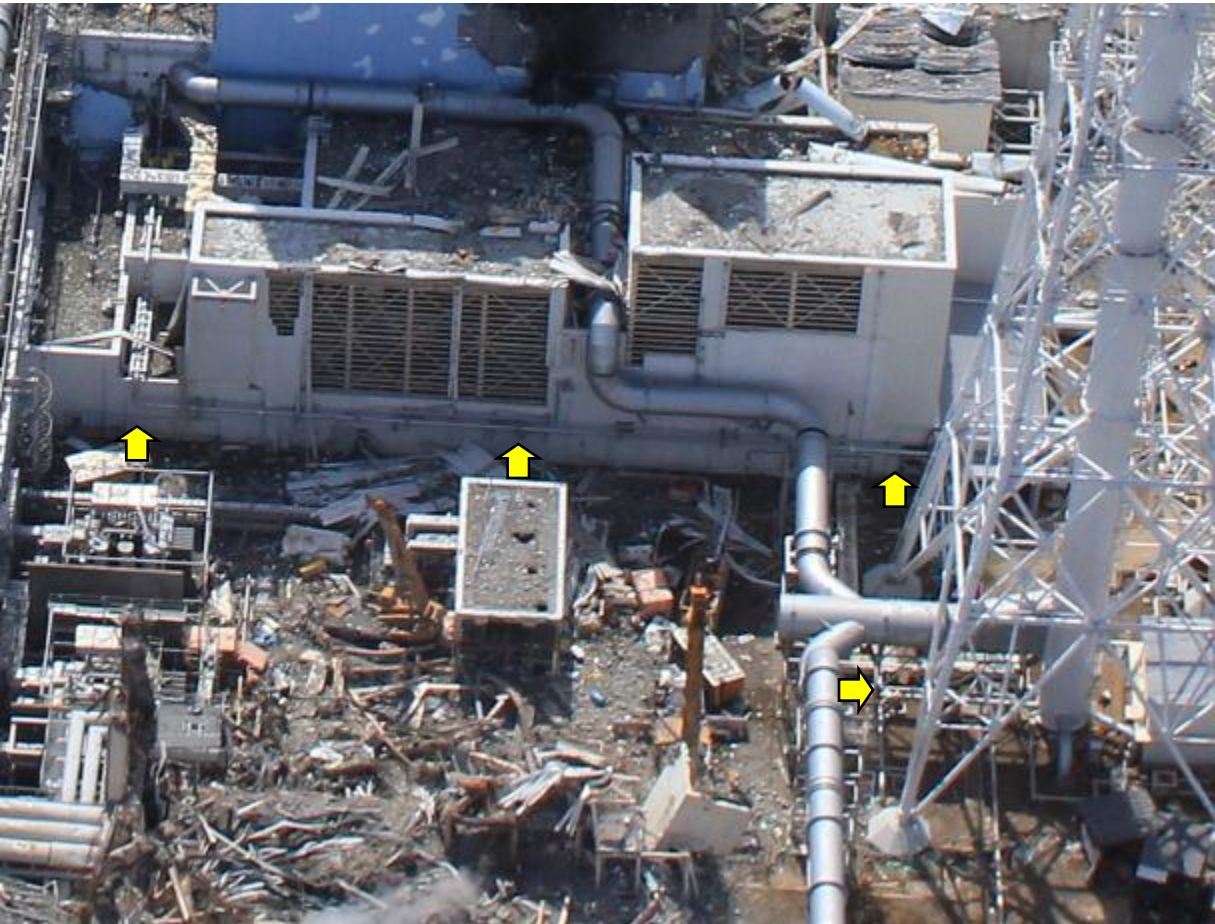
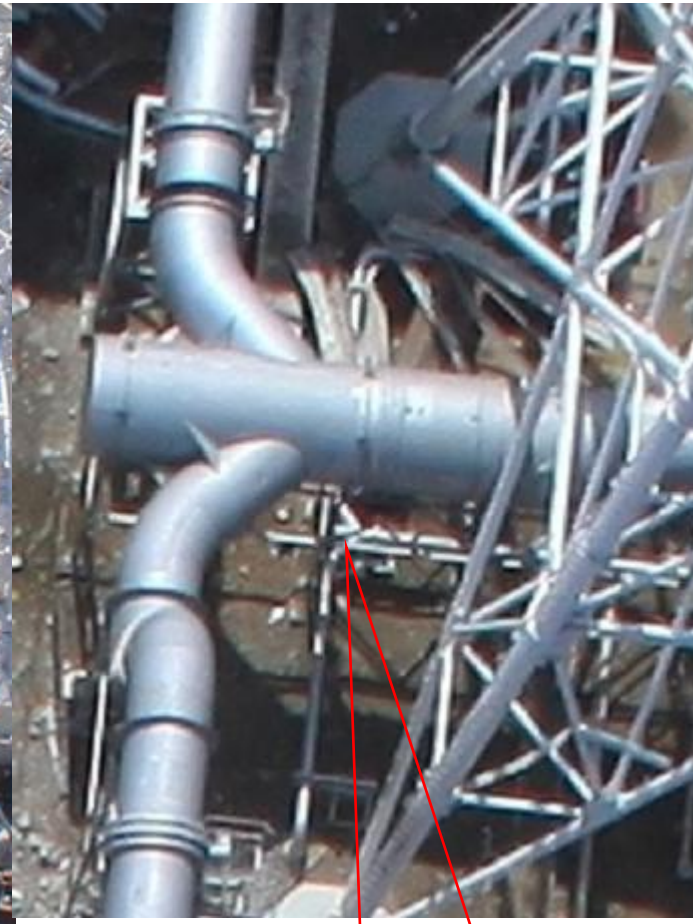
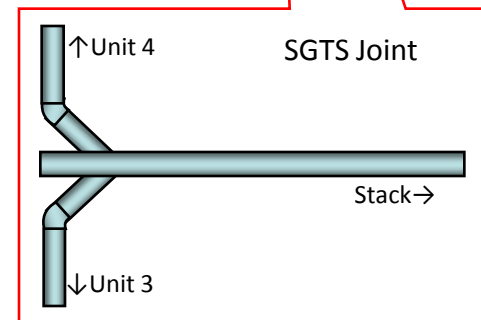
Stand-by Gas Treatment Systems for Units 3 and 4

Pipes of stand-by gas treatment systems for Units 3 and 4 are connected.

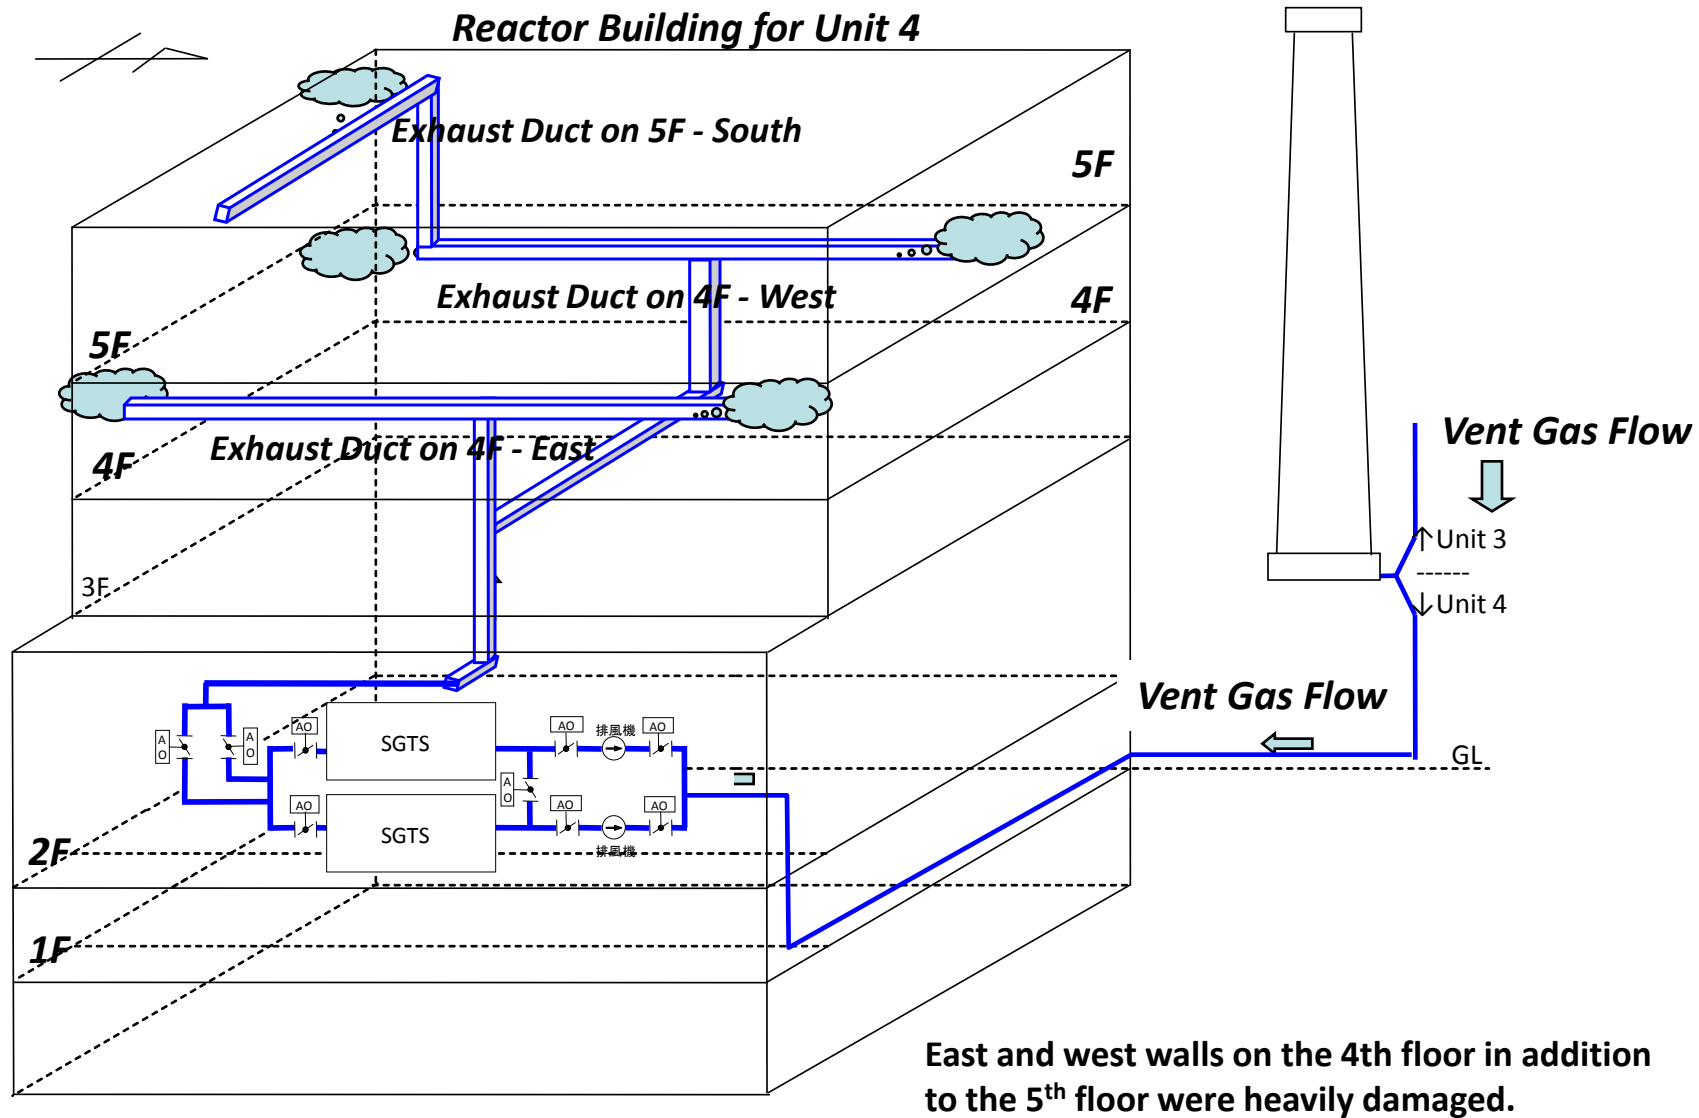
Possible Mechanism of Hydrogen Explosion in Unit 4

- At 6:12 on March 15, with loud noise and vibration, Unit 4 R/B was damaged.
- Later investigation showed that hydrogen generated in Unit 3 flew into Unit 4
 - There is a possible path from PCV vent line shared by Unit 3&4 through Unit 4 SGTS line into Unit 4 R/B
 - Fuels in spent fuel pool (SFP) are not damaged.

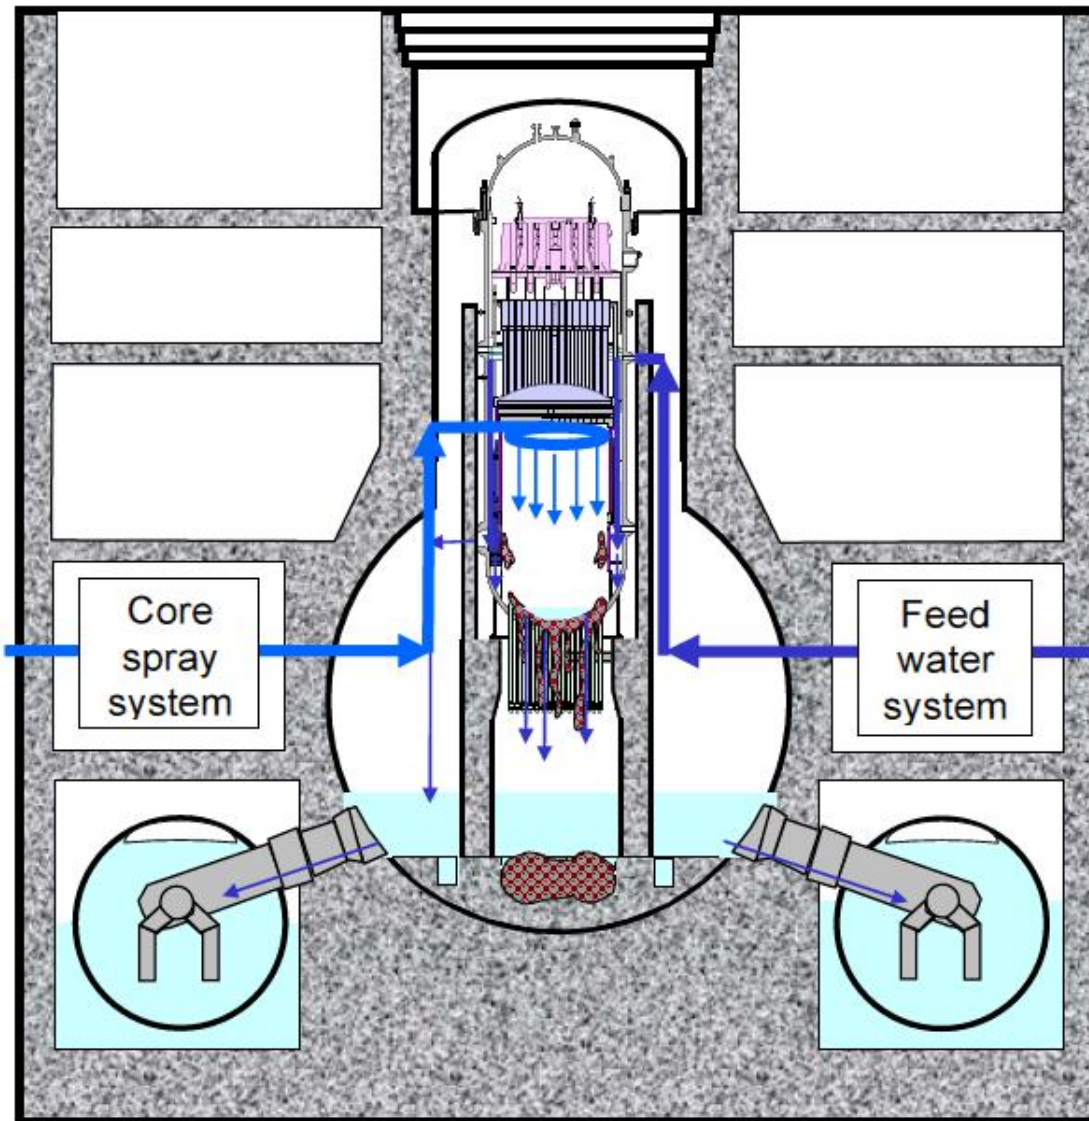
Summary of Core Damage in Unit 1

- Severe Accident code analysis indicates;

All fuel rods were melted and relocated to the RPV bottom. Considerable amount of fuel dropped to the PCV bottom.

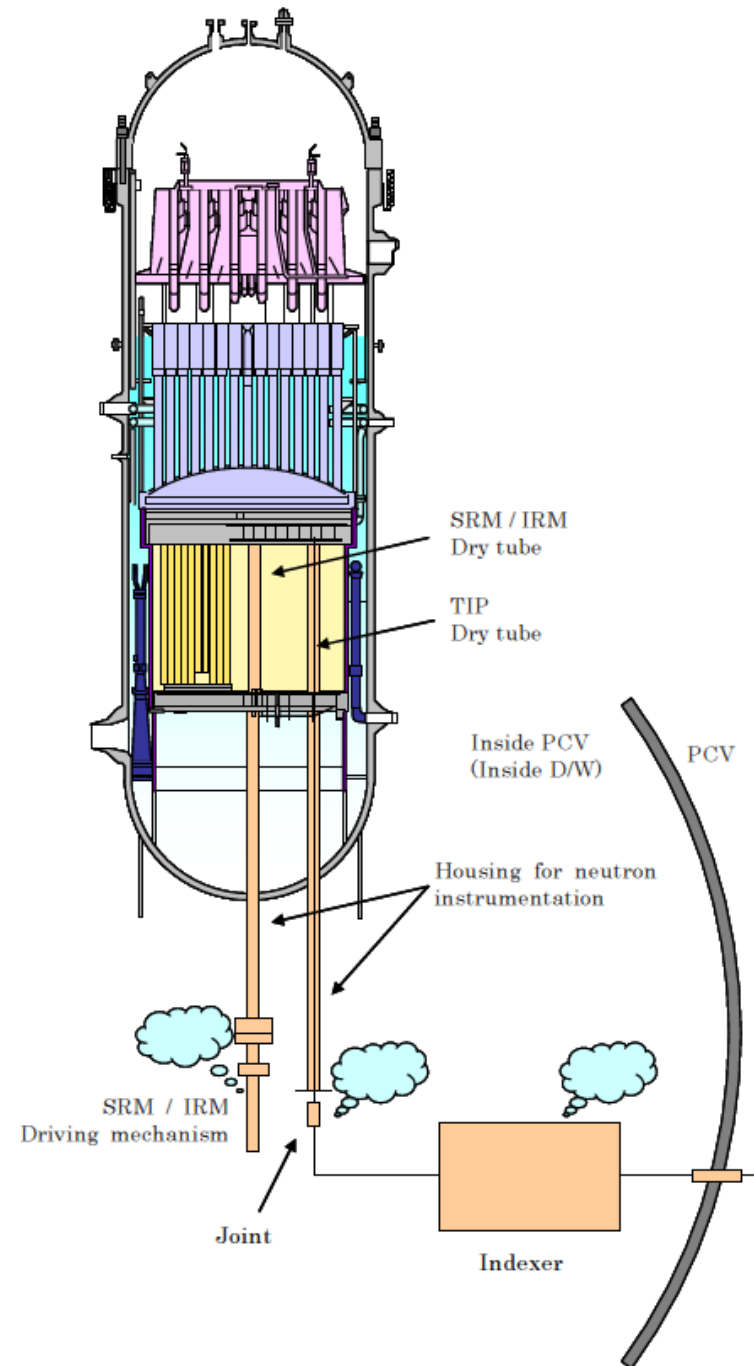
Location of Gas Leak from RPV to PCV in Unit 1

- Possible paths of gaseous leakage from the reactor vessel to the D/W are the in-core instrumentation dry tube or the main steam line flange gasket.
- The in-core instrumentation dry tube can be damaged when fuel temperatures are elevated.
- The main steam line flange gasket may lose its airtightness at temperature of about 450 C.

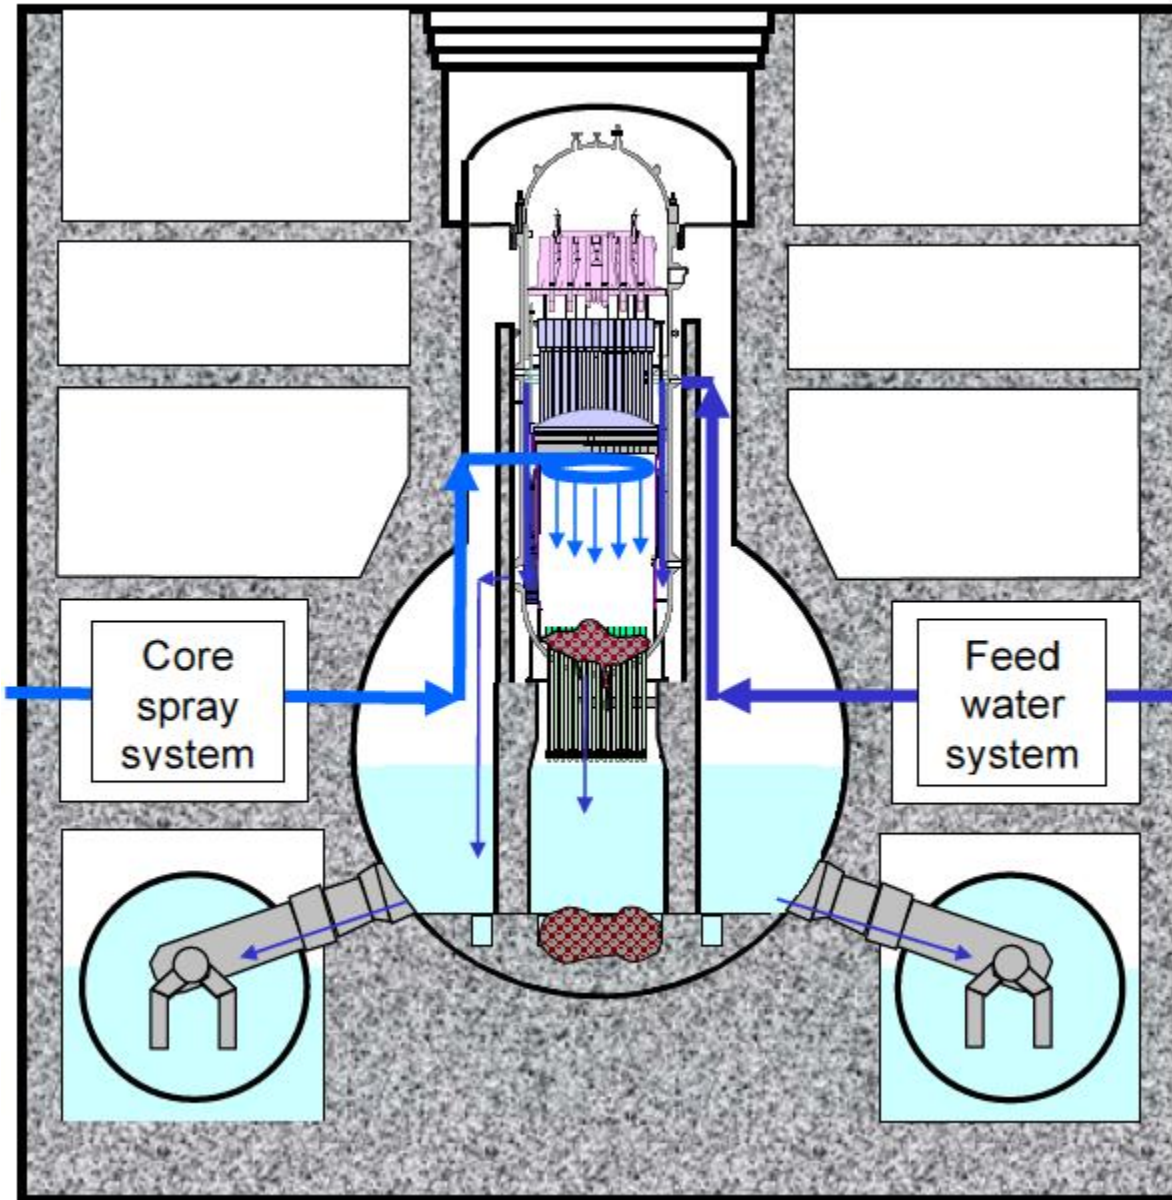
Summary of Core Damage in Unit 3

- It was possible to control the RCIC and HPCI and continue cooling, as batteries can be used.
- After RCIC stopped at 11:36 on March 12, HPCI started up automatically.
- At 20:00 on March 12, reactor pressure fell below HPCI design condition 1MPag to about 0.8 MPag. (No cooling water was injected into the reactor after that time.)
- Batteries ran out, and HPCI stopped by 2:42 on March 13.
- A hydrogen explosion occurred in the reactor building at 11:01 on March 14.

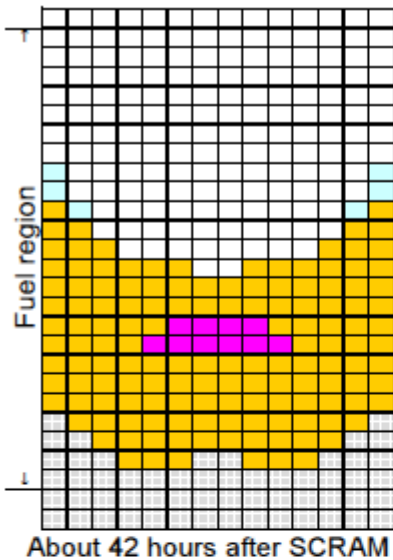
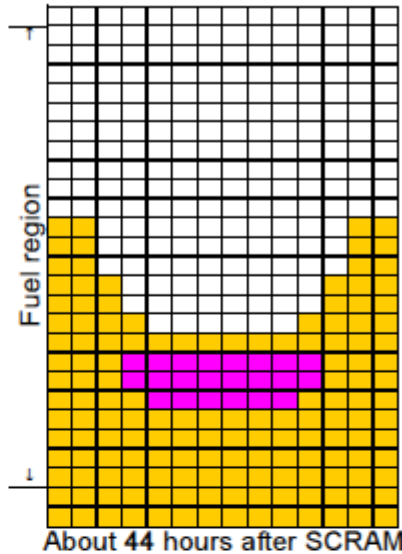
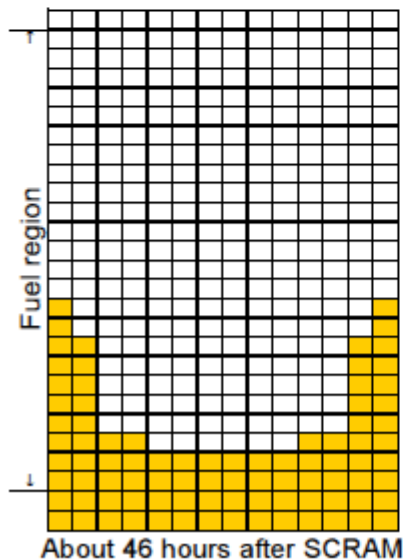
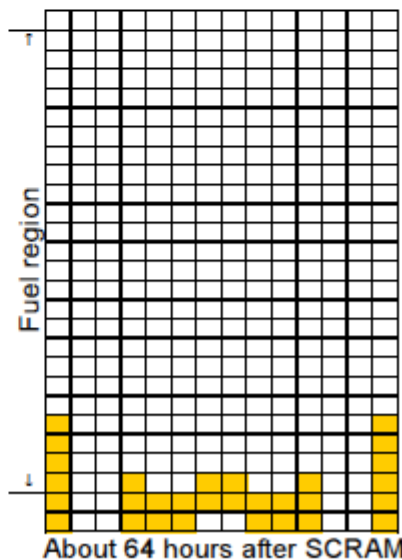
Estimated Core Damage in Unit 3

- Simulation Results by the MAAP code -

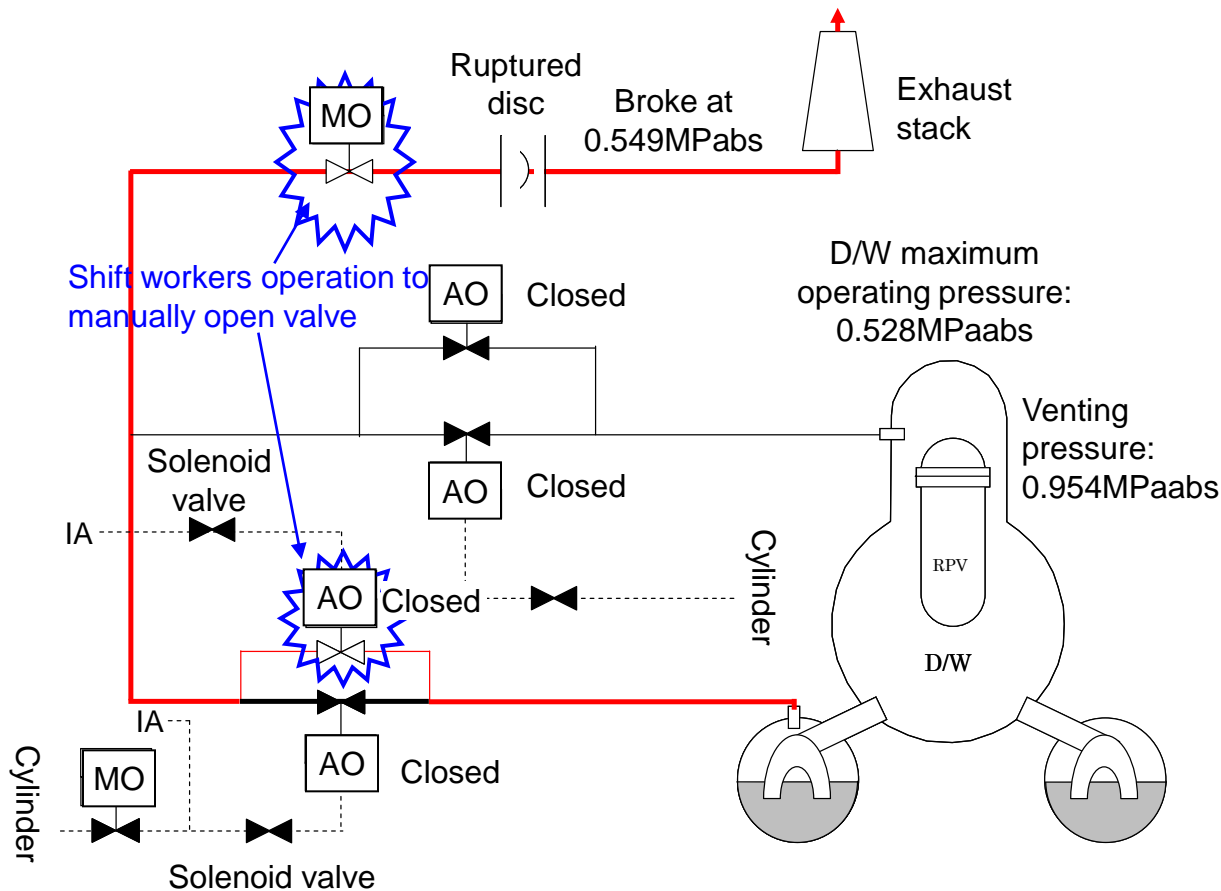
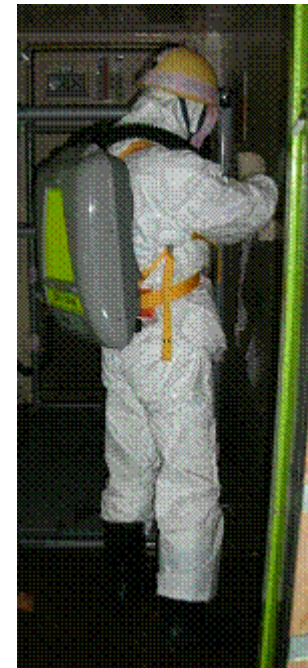
Primary Containment Vessel Venting Operation

No power source for the MO-valve
 No power source to the solenoid valve
 Low pressure to actuate the AO-valve
 High radiation level in R/B

- ➔ Manual operation
- ➔ Engine driven generator
- ➔ Engine driven air compressor
