Fukushima Daiichi Nuclear Accident;

based on the Final Report of Atomic Energy Society of Japan

Prof. Naoto Sekimura, Ph.D

Department of Nuclear Engineering and Management

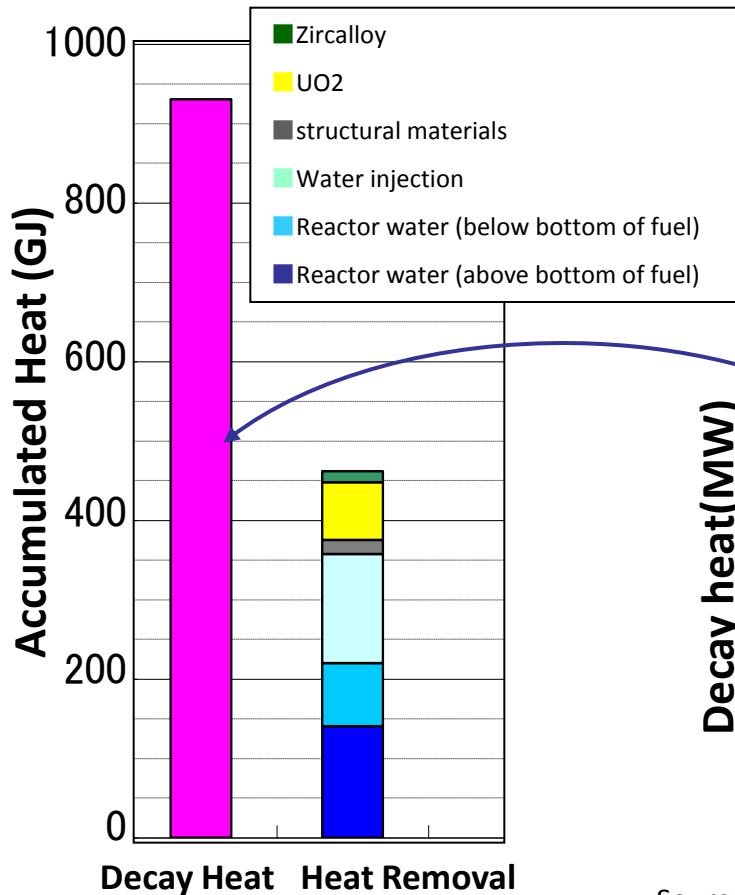
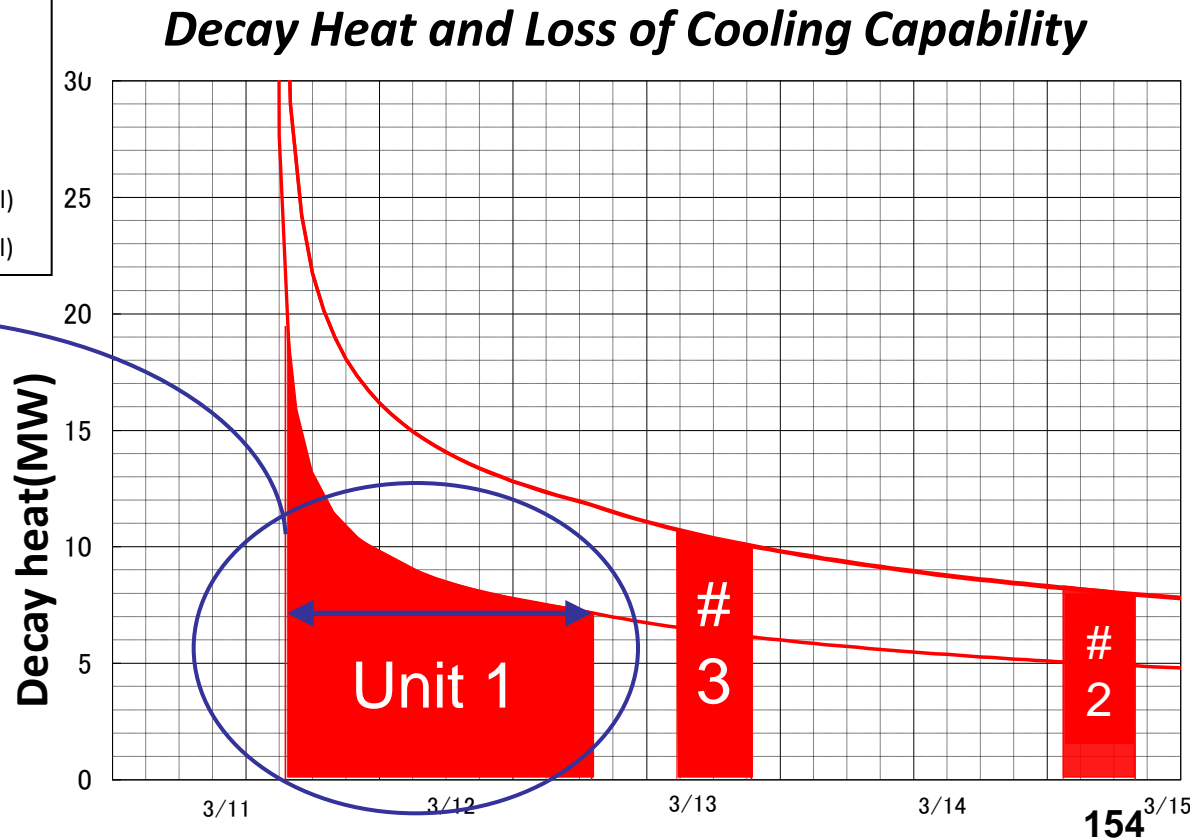
Macroscopic Balance between Decay Heat and Heat Removal in Unit 1

Decay Heat > Heat Removal

- Total decay heat before sea water injection greatly exceeds the amount of heat which reactor water and structural materials could absorb.
- All molten core moved to RPV bottom and they damaged RPV and run down to PCV.

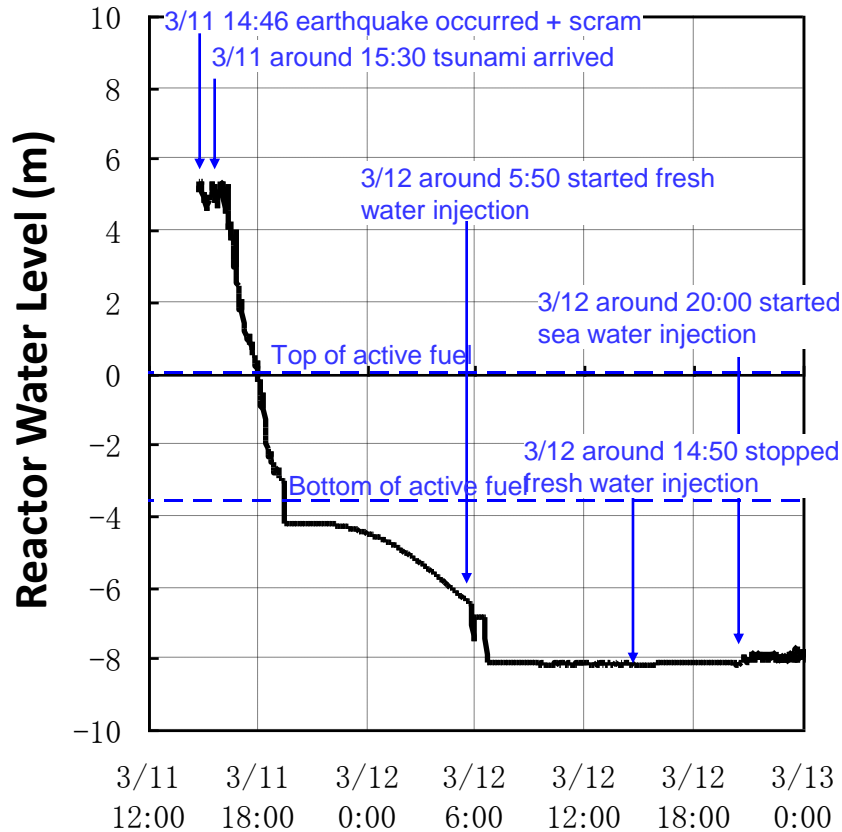
Reactor Water Level and Core Temperature in Unit 1

Assuming that IC lost its function by the Tsunami

- reached top of active fuel in 3 hours (around 18:00) after the scram
- reached bottom of active fuel in 4 and a half hours (around 19:30) after the scram

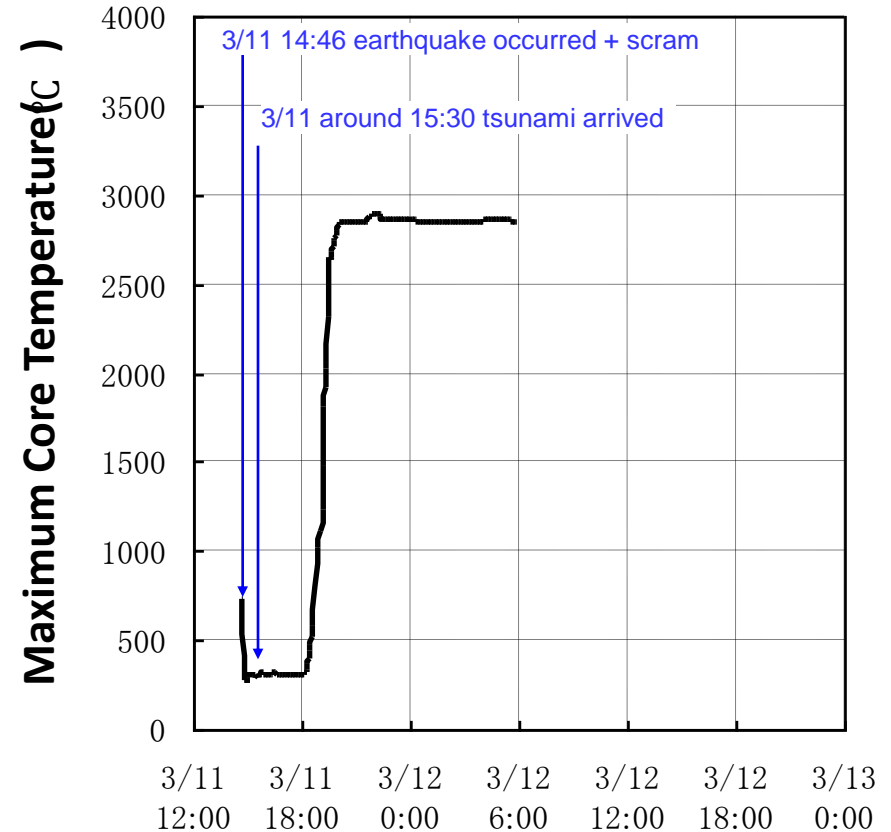
The core temperature started increasing when the reactor water level became lower than top of active fuel, then reached the core melting temperature.

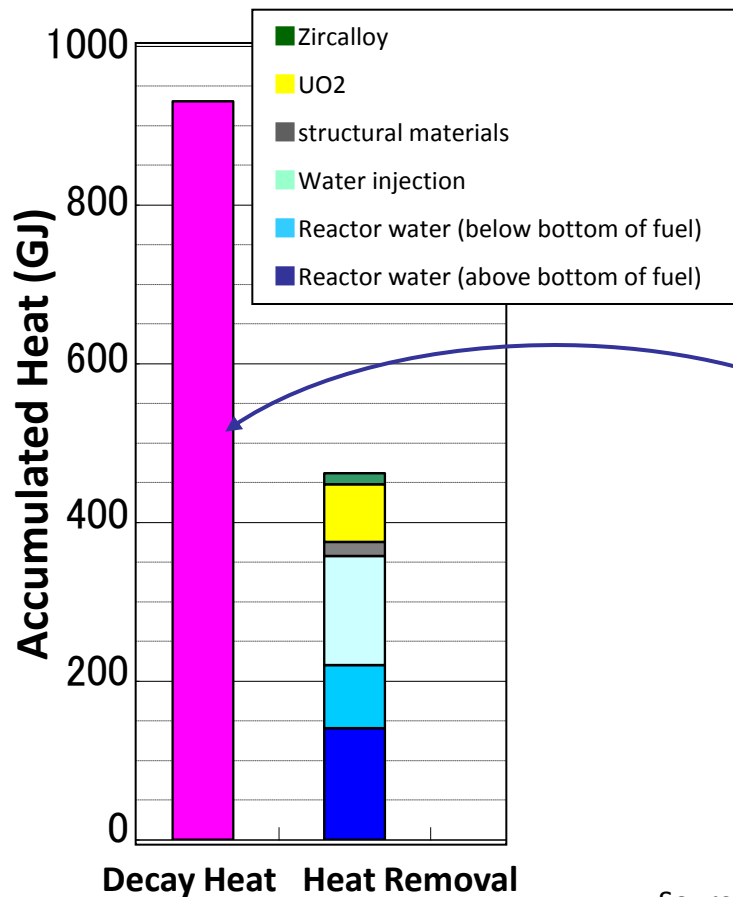
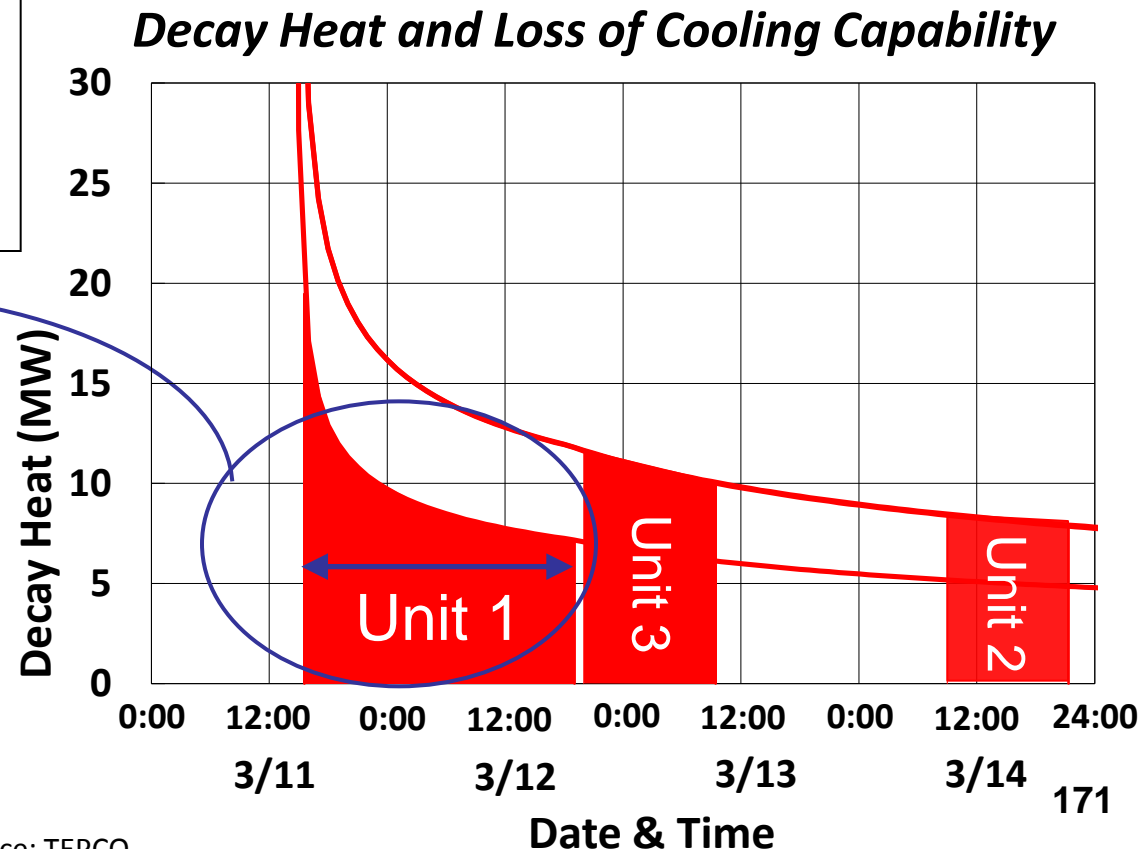
between Decay Heat and Heat Removal in Unit 1

- Total decay heat before sea water injection greatly exceeds the amount of heat which reactor water and structural materials could absorb.
- Oxidation reaction of Zr provides additional heat to promote the core damage.
- All molten core moved to RPV bottom and they damaged RPV and run down to PCV.

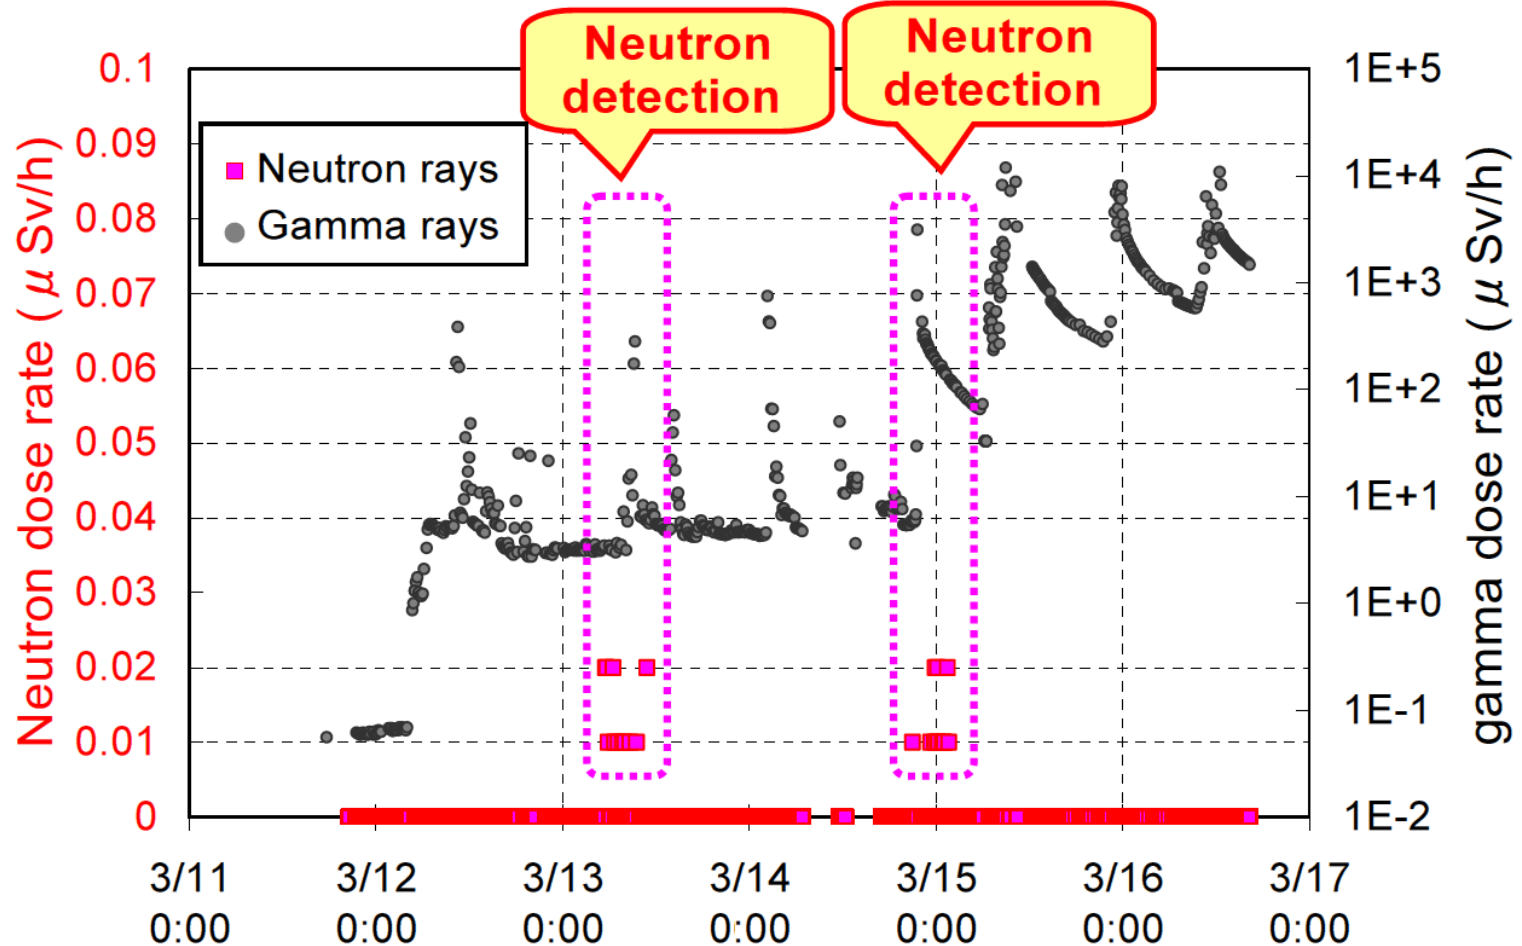
Detection of Neutrons

- Neutrons detected in the morning of March 13 and in the night of March 14 were released in the course of fuel melting at Units 3 and 2, respectively.
- Neutrons may have been generated by the spontaneous fission of released actinides.

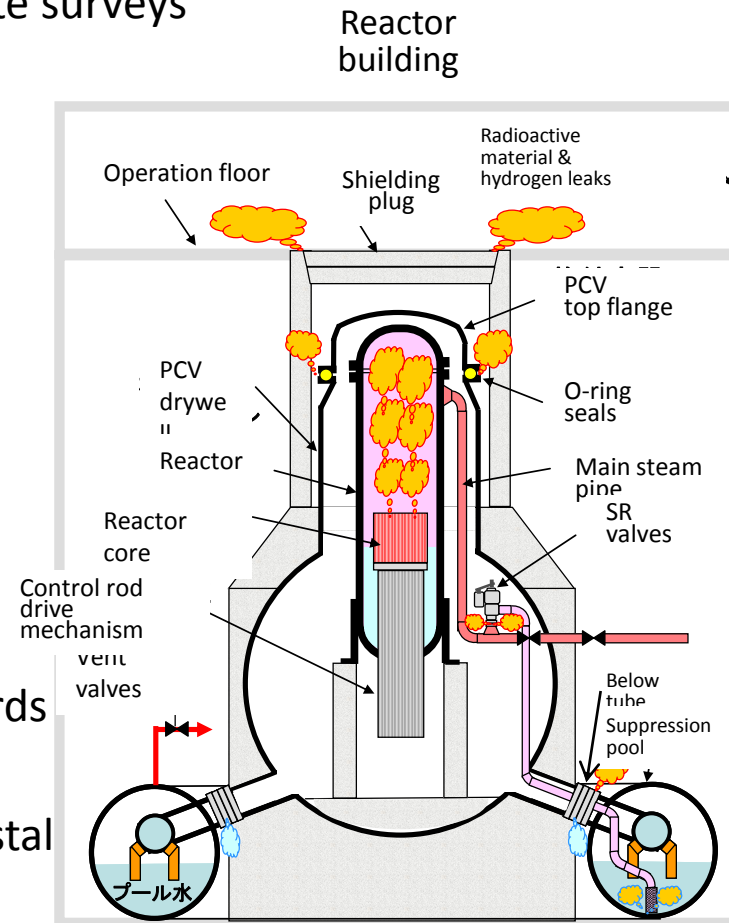
Failure of Containment Functions of PCV

- Likelihood of leaks from PCV penetrations, hatch, and silicon rubber seals of PCV upper flange (200 centigrade heat resistant)
- Need to confirm leak points by conducting onsite surveys

- Damages in the lower part of PCV, from where contaminated water is assumed to have leaked via the turbine building.
- Verified leaks from part of vent pipe in Unit 1. (Nov. 2012, report by TEPCO)
- Need to reduce leak events

- PCV cooling via containment spray and safeguards against over-pressure via filtered vents;
- safeguards against damages on the lower pedestal of PCV (e.g., coolant injection to PCV pedestal, etc.).

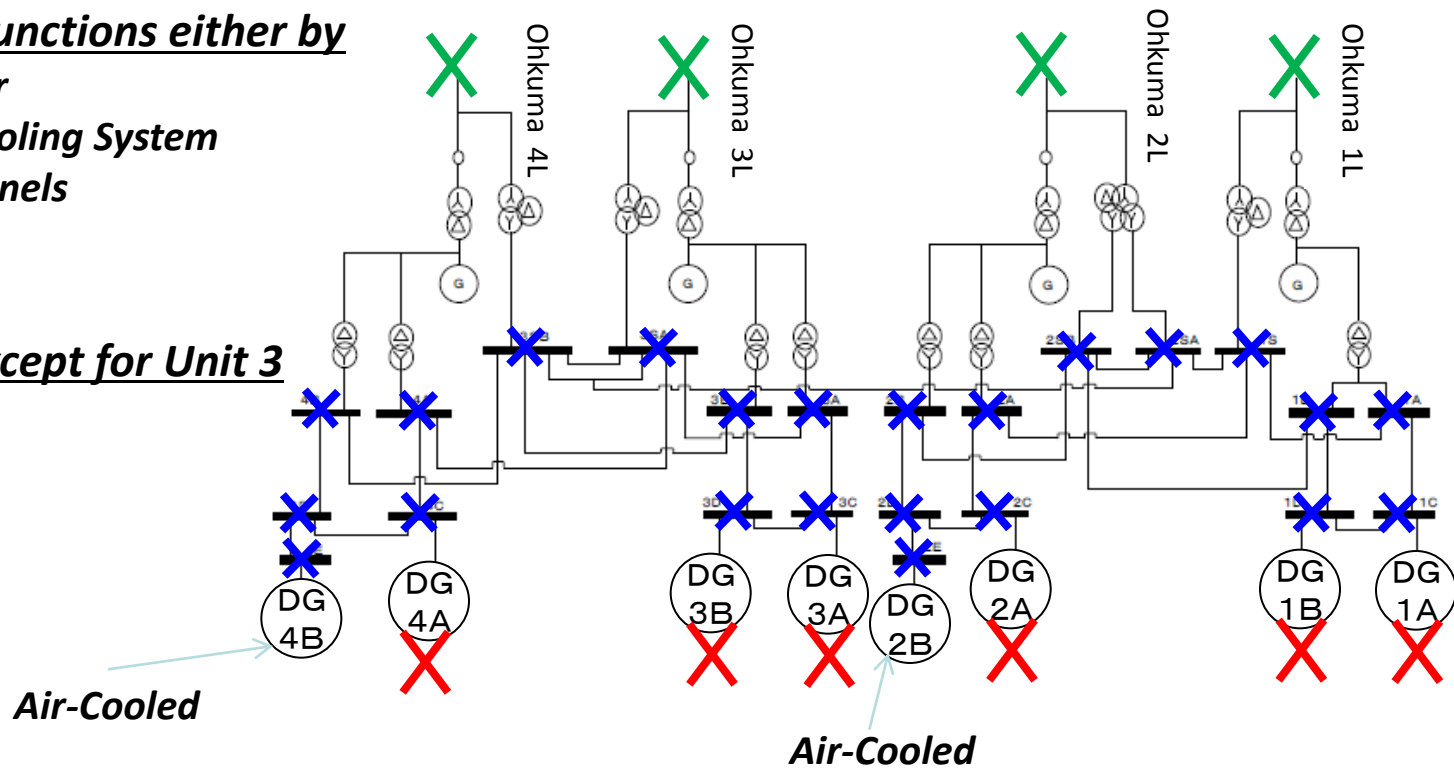
Loss of Power Supply in Units 1-4

Breakers were broken due to the earthquake

- 1) Damage in Generator
- 2) Loss of Sea-Water Cooling System
- 3) Damage at Power Panels by the Tsunami flood

Loss of DC Battery except for Unit 3

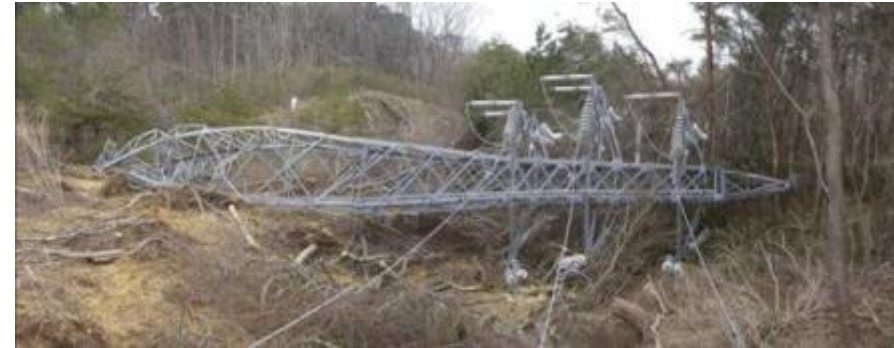
Loss of Off-site Power Supply

- Collapse of Pylons by the Earthquake

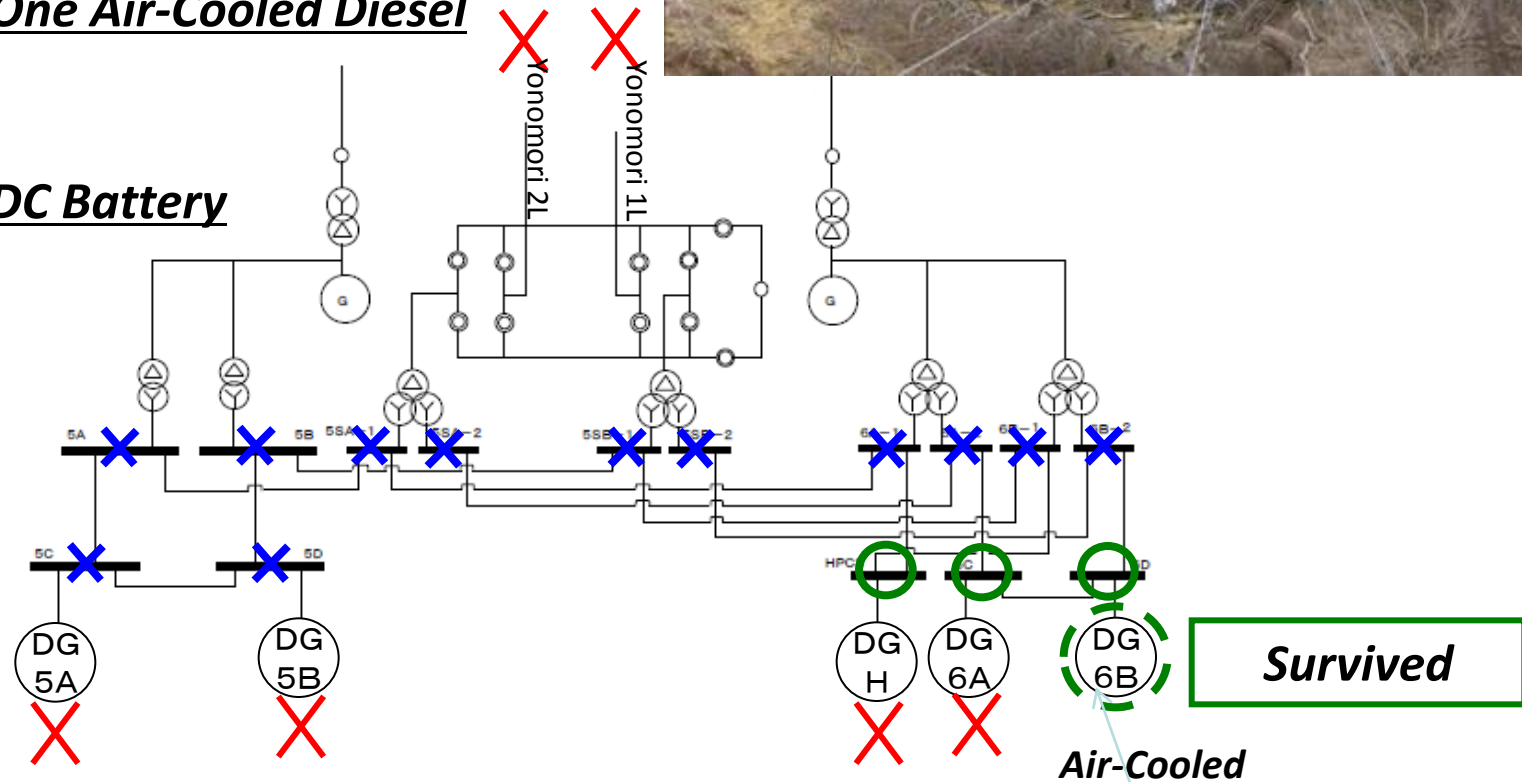
Survival of One Air-Cooled Diesel Generator

Survival of DC Battery

Damage in sea-water cooled EDGs by the Tsunami

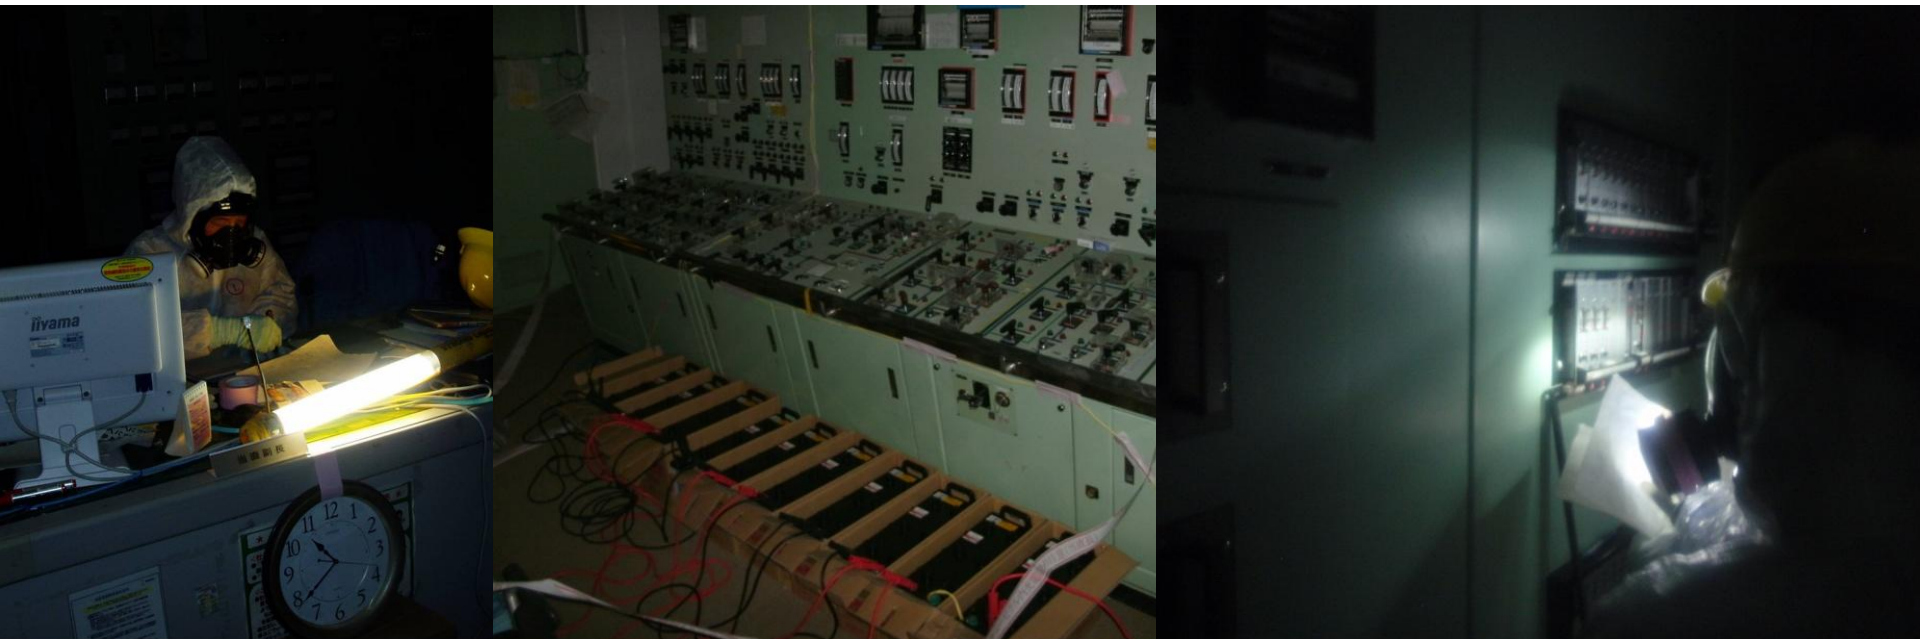
Photographs from One of the Fukushima 50

- **After the Tsunami,**
 - **No lighting available**
 - **What they can get are flashlights, batteries (some are removed from automobiles), fire trucks and some compressors**
 - **Very difficult to measure the major safety parameters like water level, reactor pressure, CV pressure**
 - **No communication tools between the Emergency Response Room and workers at the field**
